WILD TROUT TRUST
wildtrout.org

River Sheppey, Croscombe, Somerset

**Wild Trout Trust report on walkover surveys carried out on 13 February and 5
March 2021**

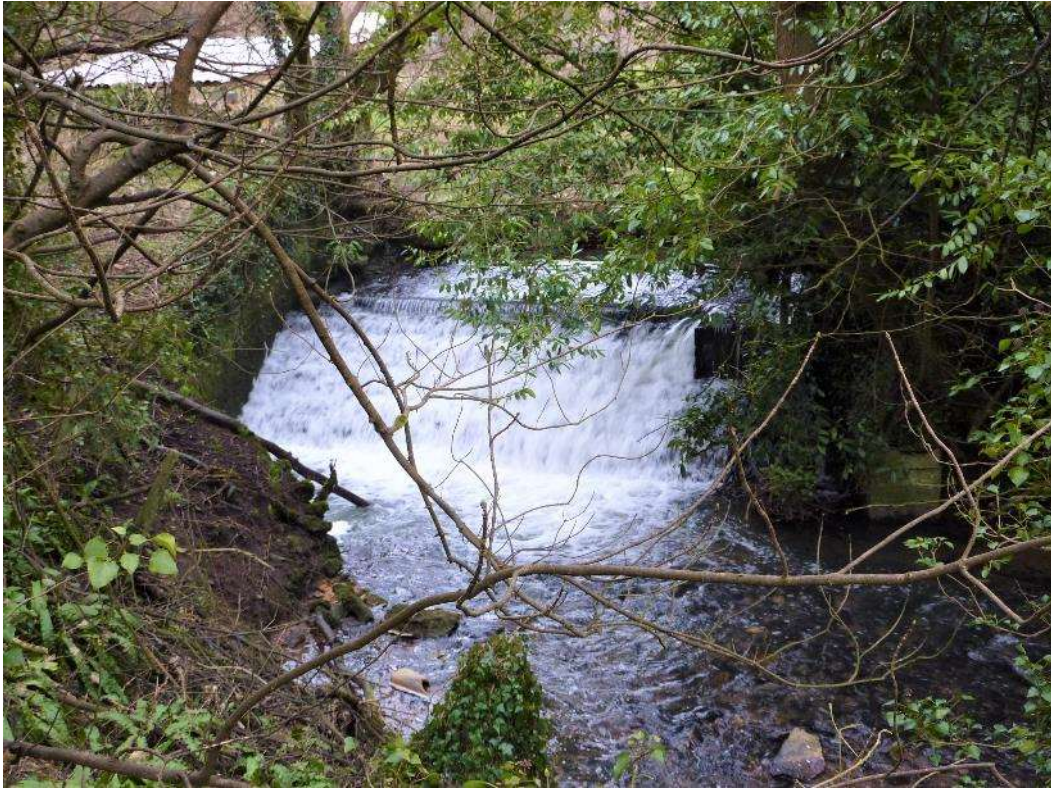
Figure 3: A redundant weir impounding the River Sheppey upstream of Croscombe

At the north-western end of the field, the river’s longitudinal connectivity is severely interrupted by a large redundant weir (as shown in Figure 3 above) at ST 59595 44305 – a relic of a long-vanished mill. As described in Appendix 3: Weirs and their impacts, such weirs have a very damaging effect on river ecology and natural processes, and options for removing this one should be investigated as soon as possible.

| Location | Photo (If required) | Priority (1-3) | Grid reference | Proposed action |
|---|---|---|---|---|
| Weir upstream of Croscombe | | 1 | ST 59595 44305 | Fish passage and habitat: remove weir and re-meander to allow fish passage and restore natural processes |

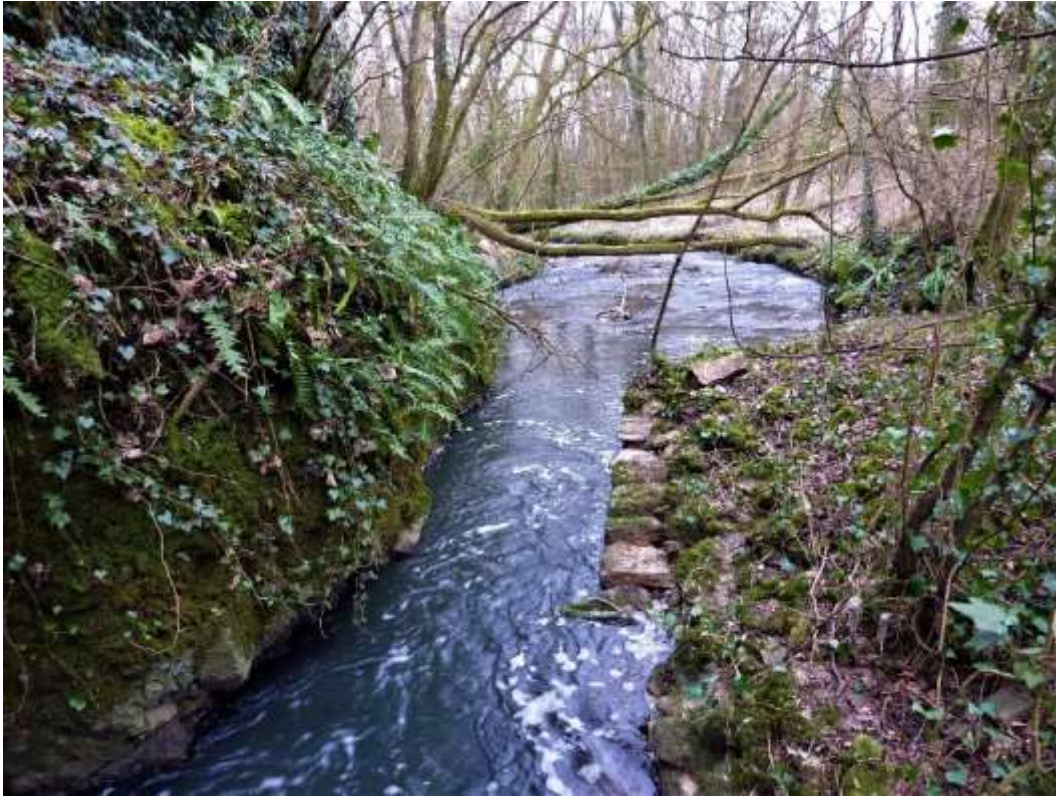
Figure 4: Looking downstream through an old milling site: the pinched channel widens out into a long riffle, where fallen trees could be dropped into the river and secured as beneficial woody material

Downstream of the weir, abundant gravel and cobbles can be seen in the channel through the remains of the old mill buildings. At one point, the river is pinched into a particularly narrow, deep channel (which may represent a pocket of good habitat for adult trout) before widening out into a long cobbly riffle.

With landowner permission, easy access to the river at this point could make it a suitable location for riverfly monitoring by members of the local community – with particular reference to any impacts caused by the Shepton Mallet STW not far upstream.

| Location | Photo (If required) | Priority (1-3) | Grid reference | Proposed action |
|---|---|---|---|---|
| Riffle at old milling site | | 1 | ST 59525 44329 | Habitat and community engagement: add LWM to channel by reducing existing fallen trees / hinging others; investigate possible weirs further downstream; possible site for riverfly monitoring |

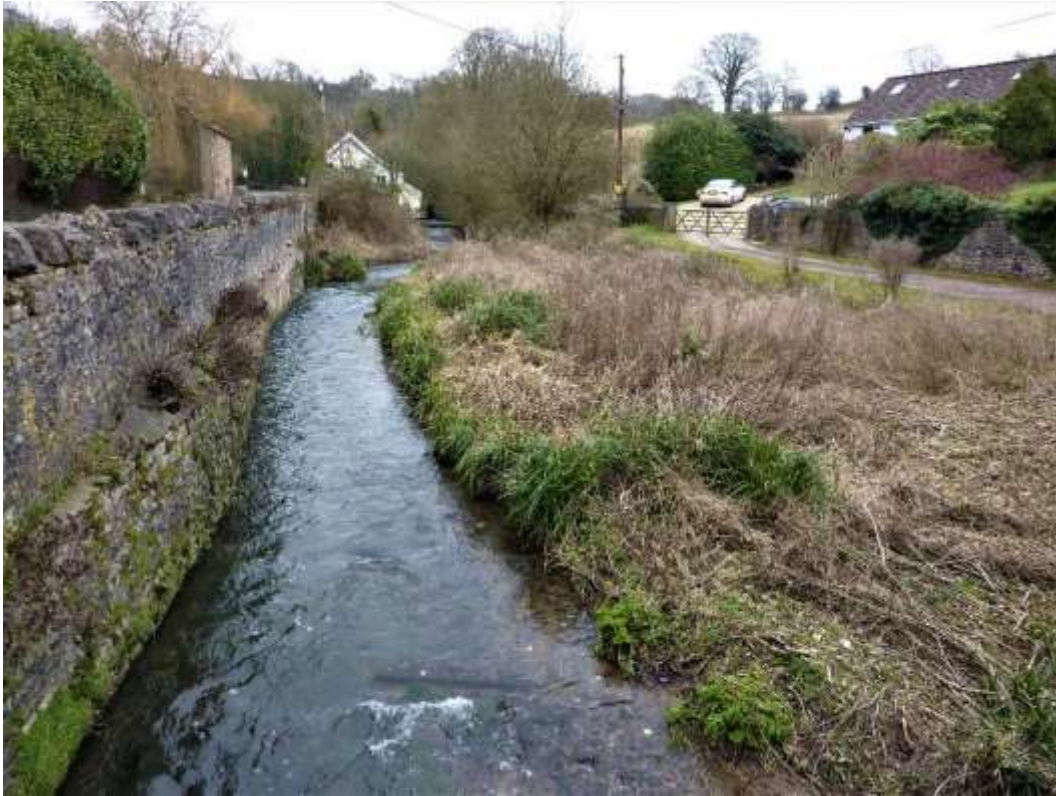
Figure 5: Looking upstream across the old mill pond, from Duncart Lane bridge

As it leaves the long riffle shown in Figure 4, the River Sheppey flows through private gardens and commercial premises where it could not easily be assessed. However, the WRT/BART 2016 survey suggests that at least one fish passage barrier may exist at ST 59462 44315 (approx.) and this will require further investigation.

In addition to increasing the length of the channel, thus reducing its gradient and 'slowing the flow' through this stretch, this extensive re-meandering would connect the river more fully to its floodplain, boosting flood storage at times of high flow, and increasing infiltration to ground water. A more sinuous channel, with greater complexity of depth and flow patterns, will also increase aesthetic benefits for local people, and provide many more habitat niches for different species and life stages of insects, birds and fish.

| Location | Photo (If required) | Priority (1-3) | Grid reference | Proposed action |
|---|---|---|---|---|
| Channel upstream of Duncart Lane bridge | | 1 | ST 52988 44298 (approx.) | Habitat: create more sinuous channel by re-meandering through footprint of old mill pond |

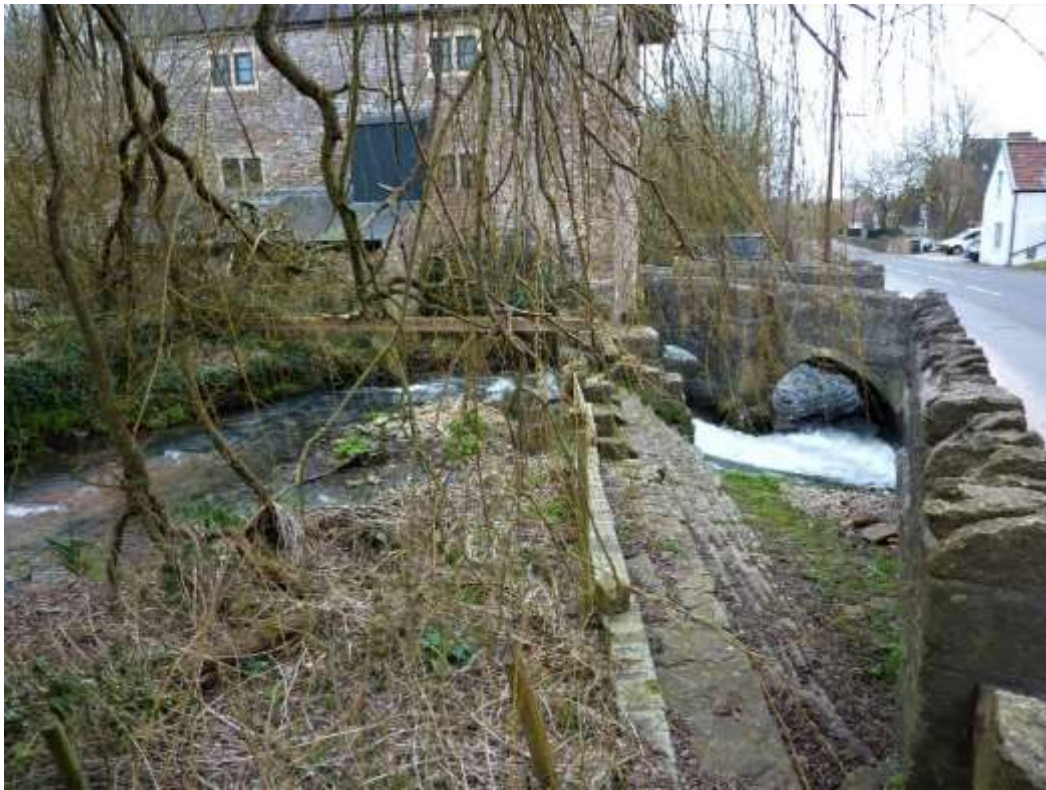
Figure 6: An impassable weir between Duncart Lane and Back Lane

Just downstream of the old mill pond illustrated in Figure 5, the River Sheppey reaches the mill pond's impounding structure – a large and complex weir shown in Figure 6 above, where the river flows through a narrow former sluice, and down a long lower weir face. This is considered to be completely impassable to fish of all species.

At the time of these walkover surveys, no invasive non-native species (INNS) were noted, but in summer 2020, several Himalayan balsam (HB) plants were seen growing on the crest of the weir. HB is a tall, shallow-rooted plant which tends to grow in dense monoculture stands that shade out native species before dying back in winter, leaving bare soil without perennial root structure to help resist erosion. Riverbank erosion can contribute significantly to riverbed sedimentation (one recent study suggests a rate of 10 tonnes per km per year) smothering gravels, invertebrates and fish eggs. More generally, HB also reduces biodiversity by suppressing native plants with allelopathic compounds in the soil and attracting insects to pollinate its flowers preferentially with its strong scent and prolific nectar.

the meantime, it would be highly beneficial to engage with the landowner to arrange local eradication of this infestation of HB, perhaps by hand-pulling with the help of volunteers.

| <p>Weir downstream of Duncart Lane bridge</p> | | <p>1</p> | <p>ST 59251 44299</p> | <p>Flood risk and fish passage: reduce height of impoundment and ease fish passage through weir (possibly by deepening notch or constructing a rock ramp along the RB)</p> |

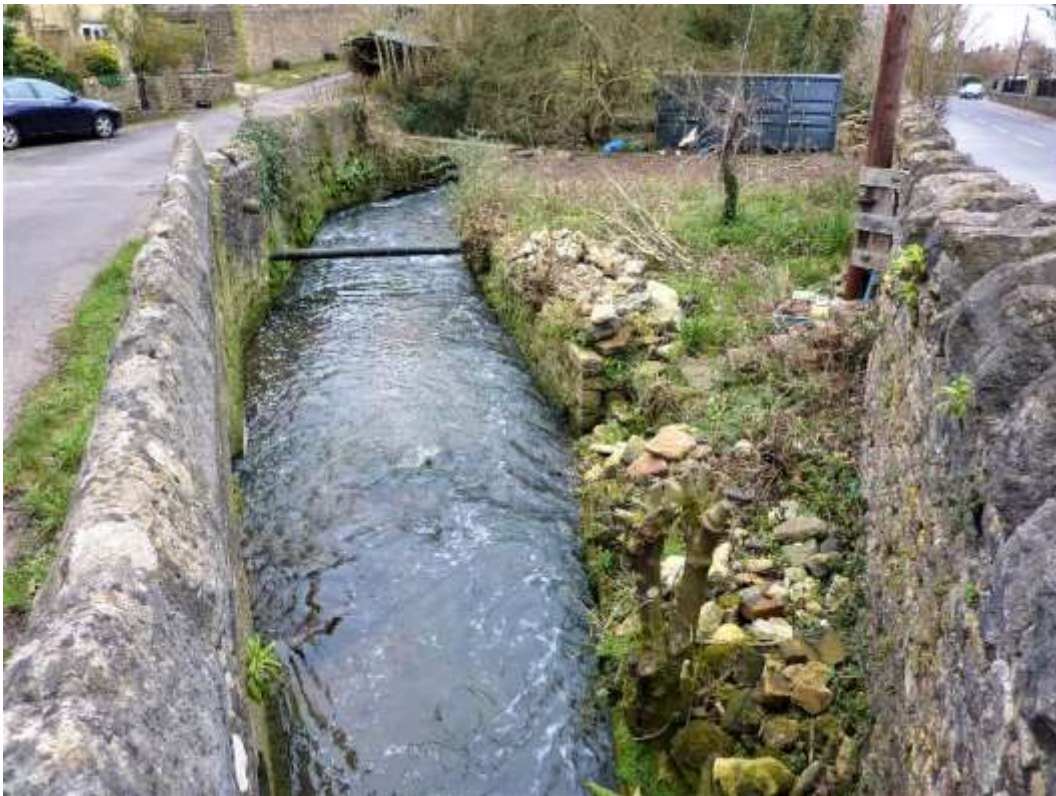
Figure 7: Looking downstream from Back Lane bridge, with deteriorating retaining walls on the RB

Proceeding downstream from Back Lane bridge, the River Sheppey enters a semi-cultivated garden area, before flowing under the A371 Long Street in a deep culvert. It was noted that this culvert entrance is rather low and small, suggesting that it may act as a throttle on higher flows. As such, the stretch of river and its adjoining gardens immediately upstream may become a useful flood attenuation area.

This stretch of the river is still constrained between high walls, but some of the walls adjoining the RB gardens are visibly deteriorating - suggesting that it would be relatively easy as well as beneficial to remove them completely, and replace with a soft, well-vegetated bank toe. This would benefit many species of insects, birds and fish, by creating a more gradual transition between different habitats in varying high and low flows.

Finally, it was noted that sewer pipe also crosses the area: this would be threatened by any uncontrolled collapse of the existing stone revetments, so a bank softening project should include securing the integrity of the pipe (which should also be periodically inspected by Wessex Water in any case).

| <p>Channel downstream of Back Lane bridge</p> | | <p>2</p> | <p>ST 59213 44301 (approx.)</p> | <p>Flood risk and habitat: 'slow the flow' and reduce flood risk by breaking out hard wall on RB and adding LWM in conjunction with a soft vegetated toe; also secure the integrity of the sewer pipe crossing this area</p> |

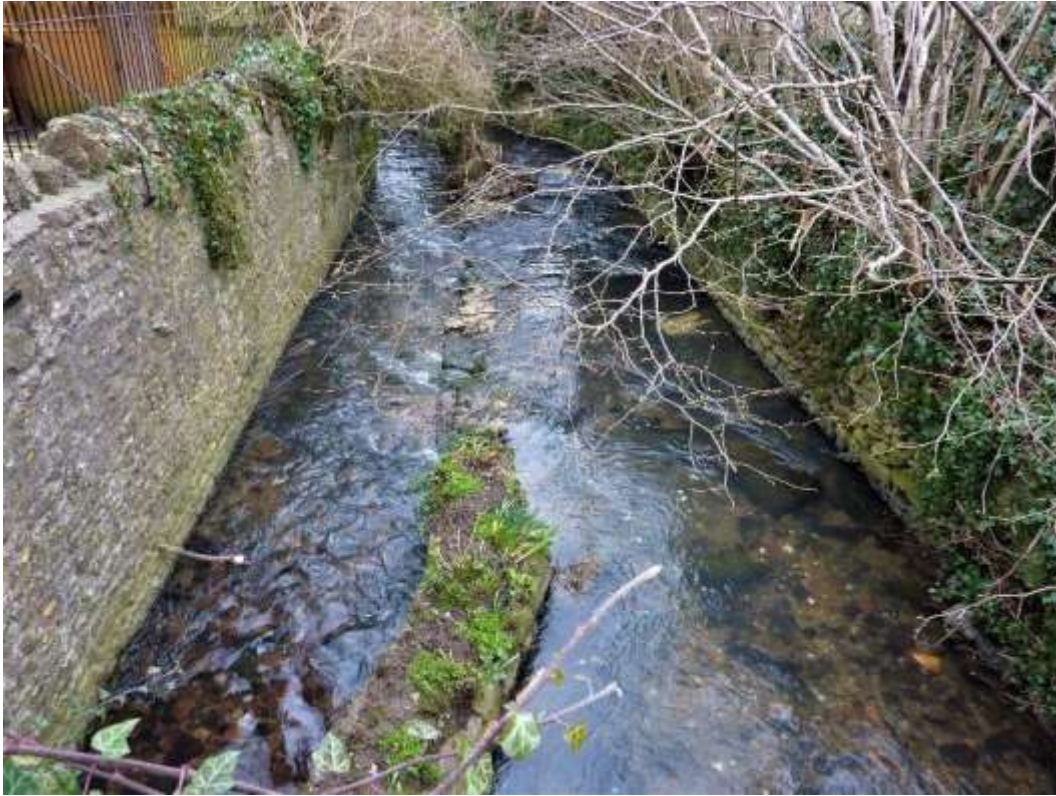
Figure 8: A mid-channel wall which is probably damaging the river's ecology in low flows

From a point just upstream from the A371 Long Street bridge, the River Sheppey continues to flow between high retaining walls, but is now also divided into two parallel streams by a central wall, probably designed to split and control flows over the weir system at ST 59131 44343.

Although the mid-channel walls are now deteriorating, this split of flows (as well as the weirs themselves) is redundant, and indeed may be causing quite significant environmental damage in times of drought - by artificially spreading available flow across the full, excessively uniform width of the channel, instead of allowing it to flow in a single naturalistic 'thalweg'.

As such, the central wall in this stretch should be removed, with rock arisings redistributed within the channel as low-level berms, and LWM introduced to promote a more natural, sinuous flow. With flows more focused in a single channel, marginal areas could also be softened with plantings of native vegetation, dramatically increasing total habitat benefits for many species.

| <p>Channel behind school</p> | | <p>1</p> | <p>ST 59189 44333</p> | <p>Habitat: remove central dividing wall, redistribute rock arisings within channel and create single sinuous low flow channel; add LWM</p> |

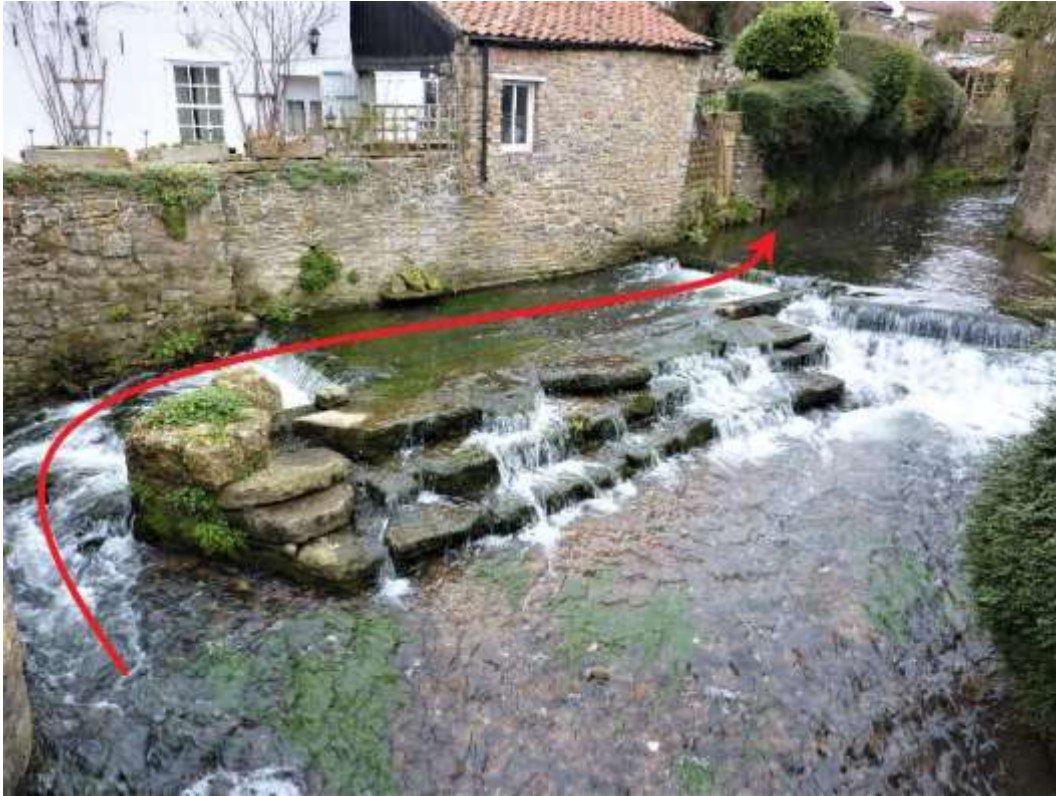
Figure 9: A complex system of weirs beside the village school, with an arrow showing a potential fish passage easement route after removing modern weir sills

After flowing around the northern boundary of Croscombe Primary School, the River Sheppey reaches a complicated (and perhaps deteriorating) system of weirs which once supplied the Middle Mill factory area (as shown in Figure 9 above).

Once again, removal of the weir would be the best option in ecological and hydromorphological terms. However, if this proves impossible, it should be feasible to remove what appear to be relatively modern sills on the western and northern side of the complex in order to achieve much better fish passage (as indicated on the image above). If necessary, a rock ramp could also be incorporated.

| <p>Weirs beside school</p> | | <p>1</p> | <p>ST 59131 44340</p> | <p>Fish passage and habitat: investigate options for fish passage (perhaps removing modern weir sills and regrading through the area)</p> |

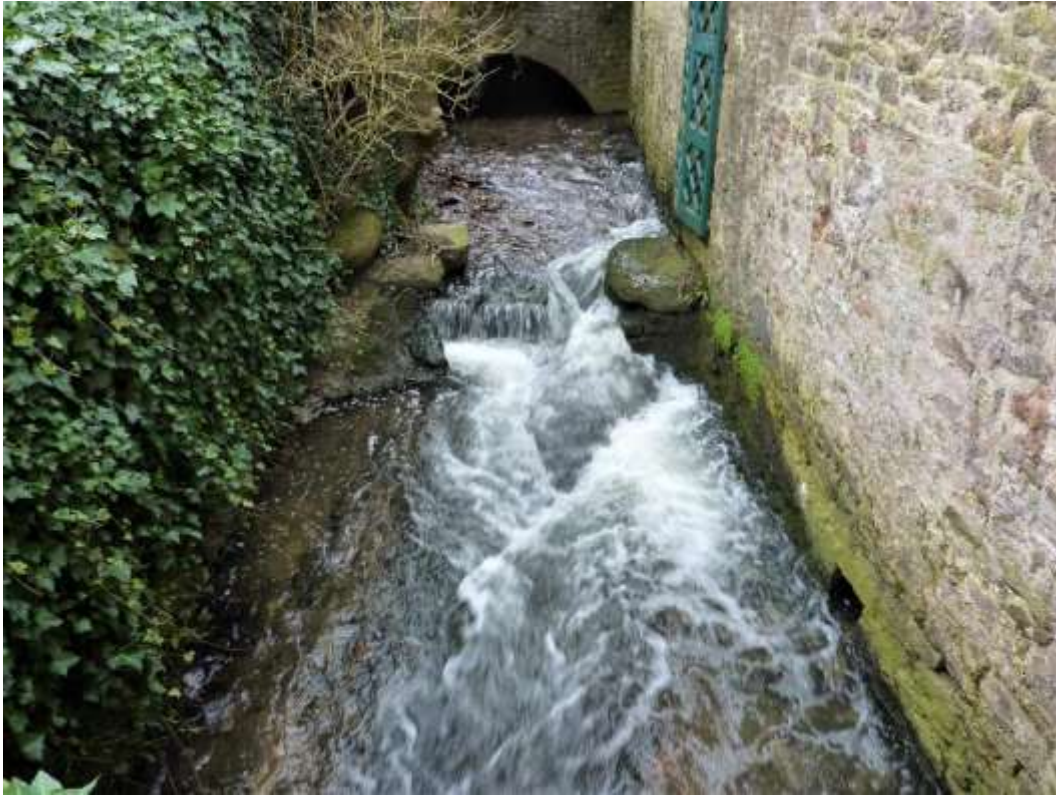
Figure 10: Small but potentially significant: a weir in the torrential bypass channel at Middle Mill

Alongside a small private access lane at ST 59107 44327 (approx.) the River Sheppey reappears briefly from a culvert below the A371 road, before plunging into another culvert, under part of the former Middle Mill area.

This structure should be removed if possible, and the rest of this short stretch of artificial channel made more hospitable, for a range of species, by adding anchored boulders to create a more diverse and sinuous flow pattern.

| <p>Channel downstream of A371</p> | | <p>3</p> | <p>ST 62220 43717</p> | <p>Fish passage and habitat: remove small weir and add anchored boulders for habitat value</p> |

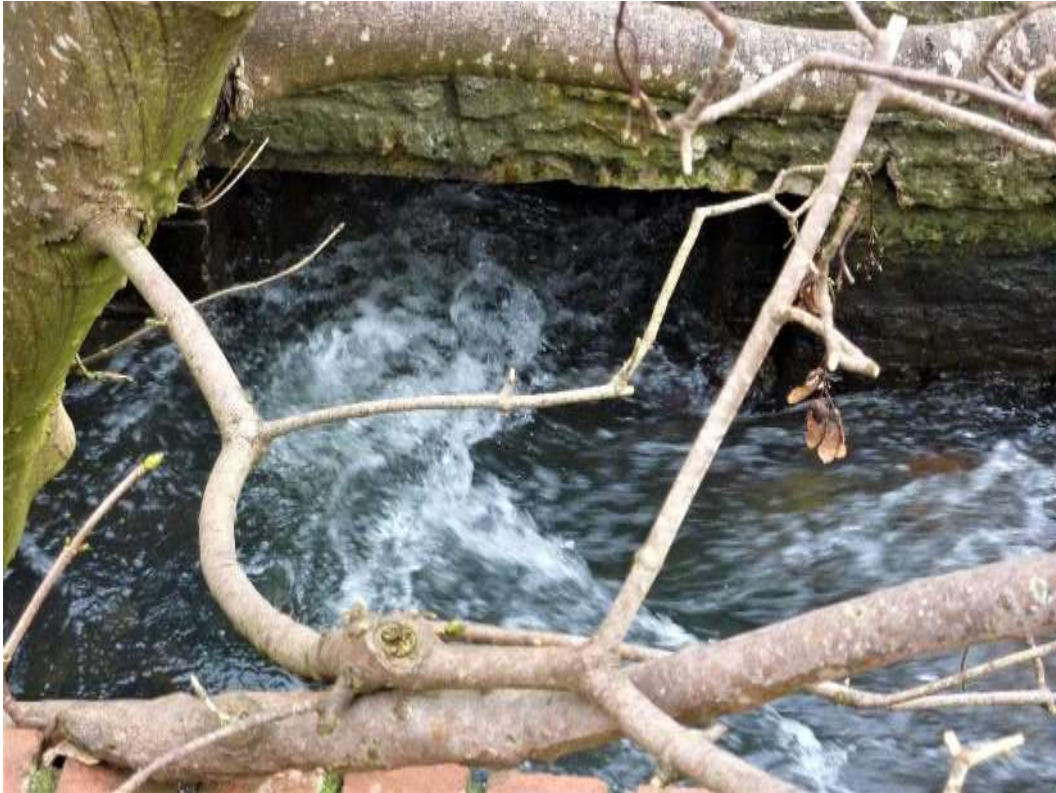
Figure 11: A dog-leg culvert, with integrated weir(s), under Old Street Lane

At the downstream end of Middle Mill at ST 58958 44304, the River Sheppey re-emerges from private gardens, and plunges 90 degrees right into a deep culvert, including one or more small weirs, under Old Street Lane and possibly the corner of an adjacent building.

Due to the water levels impounded by this complex structure, nearby properties are likely to have some of the highest flood risk in the village, and could benefit from interventions to improve fish passage, and reduce the height of the impoundment and the pinch point created by the culvert: further investigation is recommended.

| <p>Weir(s) and culvert under Old Street Lane bridge</p> | | <p>1 - 3</p> | <p>ST 58958 44304</p> | <p>Flood risk and fish passage: investigate reducing impoundment and easing fish passage</p> |

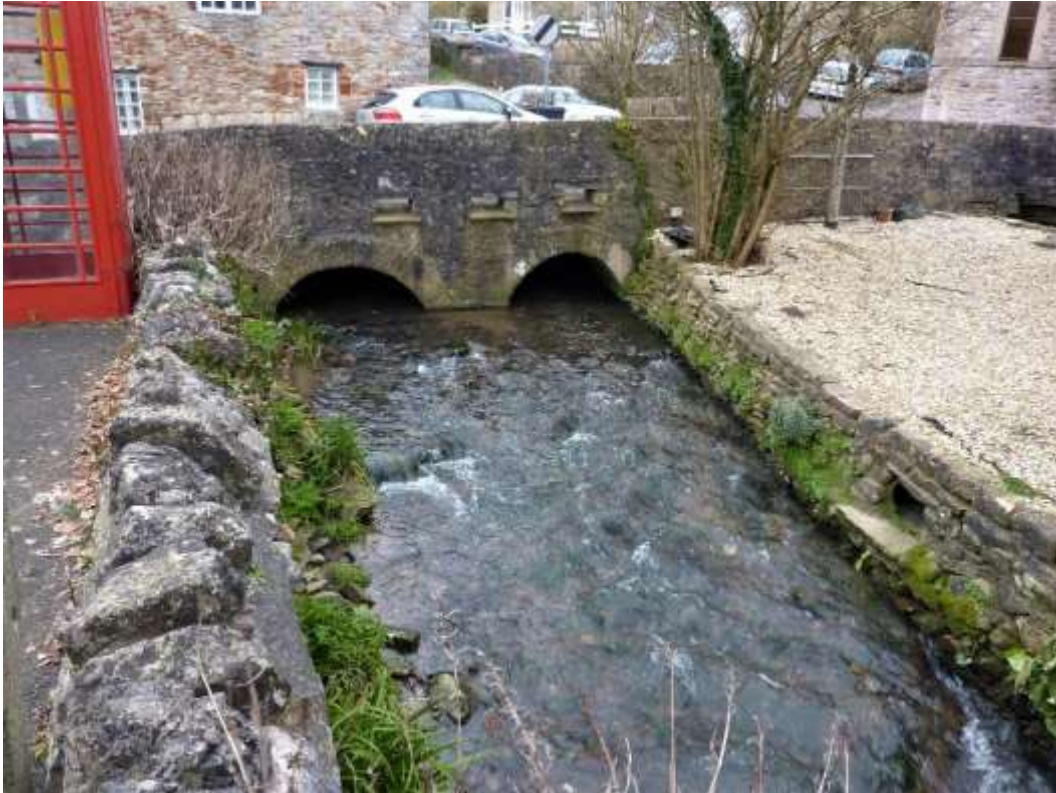
Figure 12: At Old Street Lane bridge, small marginal berms could be formalised, with small but significant habitat and visual benefits. In this area and further downstream, small perturbation boulders could also be added to increase habitat diversity

At the upstream end of this reach, at Old Street Lane (as shown in Figure 12 above) the existing small marginal low-level berms could be formalised and augmented by redistributing additional substrate from within the channel, before planting with attractive native flowering species such as purple loosestrife and hemp agrimony – increasing visual amenity and drawing attention to the river as a positive local asset, instead of simply a flood risk and possible source of pollution. On both sides of the river, soft berms like these could also help to pinch the channel slightly in low flows, creating a more dynamic and sinuous course within the existing hardened platform.

| <p>Channel downstream from Old Street Lane bridge</p> | | <p>1</p> | <p>ST 58947 44317 to ST 58888 44330</p> | <p>Habitat: retain and enhance existing marginal berms; add low level boulder gardens; monitor impact of CSO with riverfly monitoring</p> |

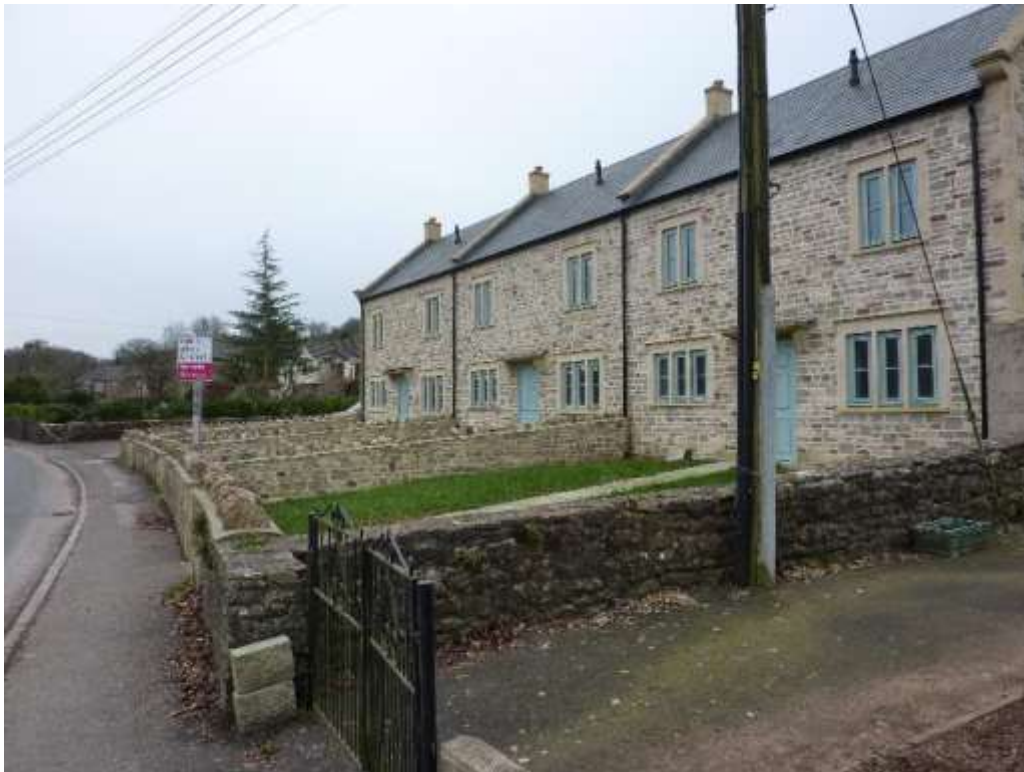
Figure 13: A recent housing development along the A371, with the River Sheppey disappointingly still culverted under its front gardens – a major missed opportunity to reduce flood risk and increase the aesthetics of the village

Between ST 58887 44330 and ST 58739 44372, the River Sheppey disappears into a long culvert, mainly under private gardens, before it reaches the site of Croscombe's former corn mill at the lower end of the village.

As in all urban and semi-urban areas, it would be beneficial to engage with local residents to highlight these potential issues and communicate the benefits of 'river-friendly gardening': solving misconnections, and promoting use of water butts, rain gardens, and permeable paving, as well as softening banks and improving in-channel habitat along individual lengths of stream. This could include replacing any hard, vertical banks with sloping edges fringed with 1 – 2 metres of softly trailing waterside plants, to increase biodiversity and habitat for birds, fish and insects.

| <p>Old culvert under gardens and recent development</p> | | <p>2</p> | <p>ST 58887 44330 to ST 58739 44372</p> | <p>Flood risk, fish passage and habitat: remain alert for future opportunities to daylight redundant culverts</p> |

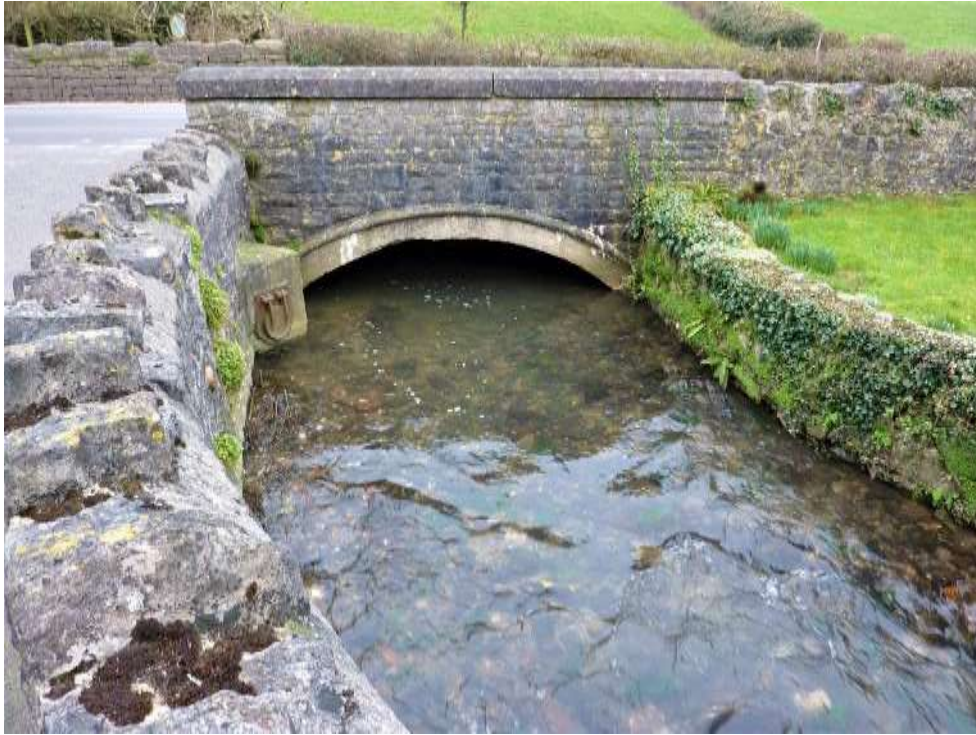
Figure 14: The River Sheppey downstream of Ham Mill

It is also noted that a CSO enters the river in this area, and the periodic impacts of this could be assessed by regular riverfly monitoring. Subject to additional landowner consent, the impacts of Croscombe STW further downstream could also be monitored.

| Channel through gardens at western end of village | | 1 | ST 58713 44361 to 58459 44422 (approx.) | Habitat and community engagement: engage with residents to implement 'river-friendly gardening'; also monitor impact of CSO (and STW further downstream) with riverfly monitoring |

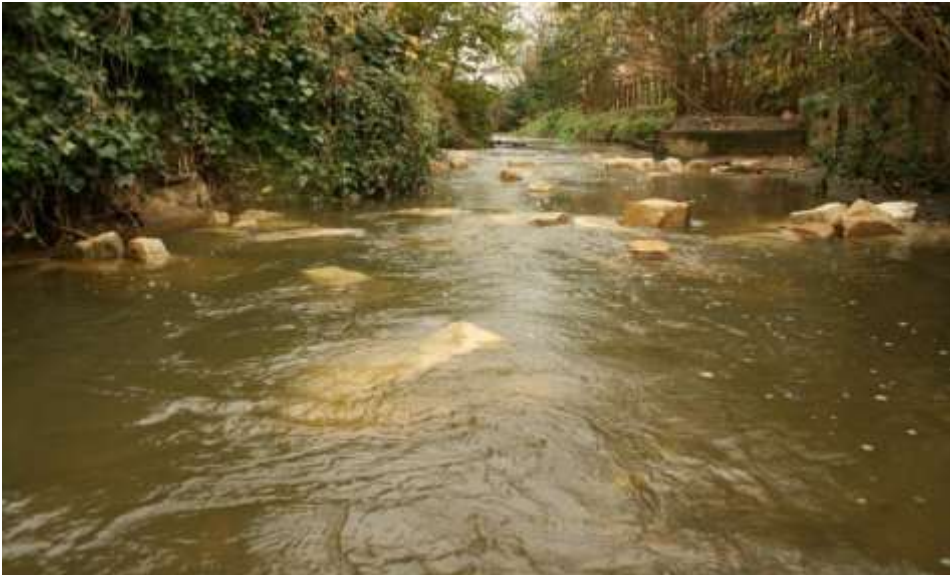
Anchored rocks and boulders

Figure 15: In hard-sided artificial channels, anchored rocks or boulders can sometimes be a more suitable solution than LWM, with a much longer (indefinite) lifespan than wood, which will degrade over time and require maintenance. In low flows, the rocks create habitat pockets for many species, while higher flows can run over the top with little impediment.

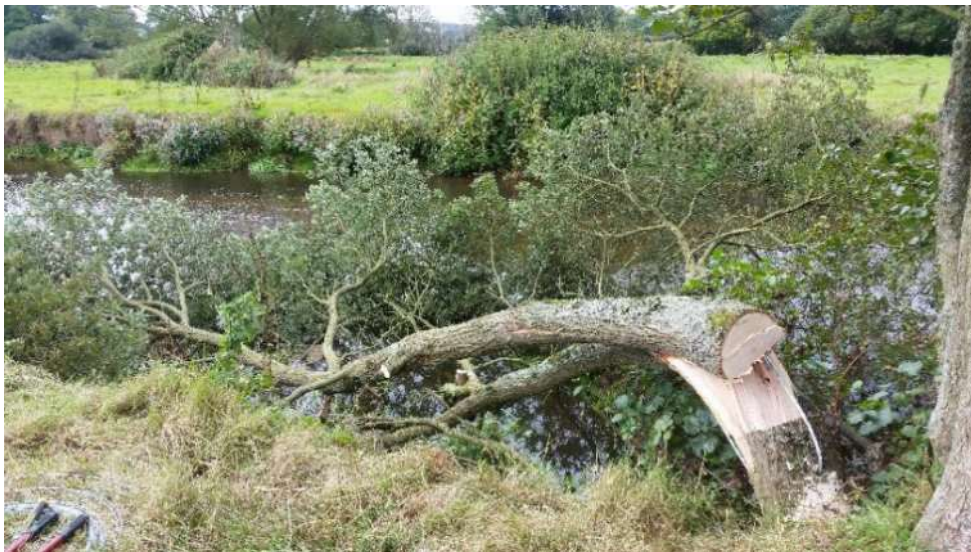
Hinged trees

Figure 16: To reduce overshading and increase habitat, bankside trees can be hinged into the edge of a river so that they can continue to grow (depending on species) and provide low-level cover for fish, insects and birds. For extra security, the branches can be staked, or the trunk can be cabled back to the stump.

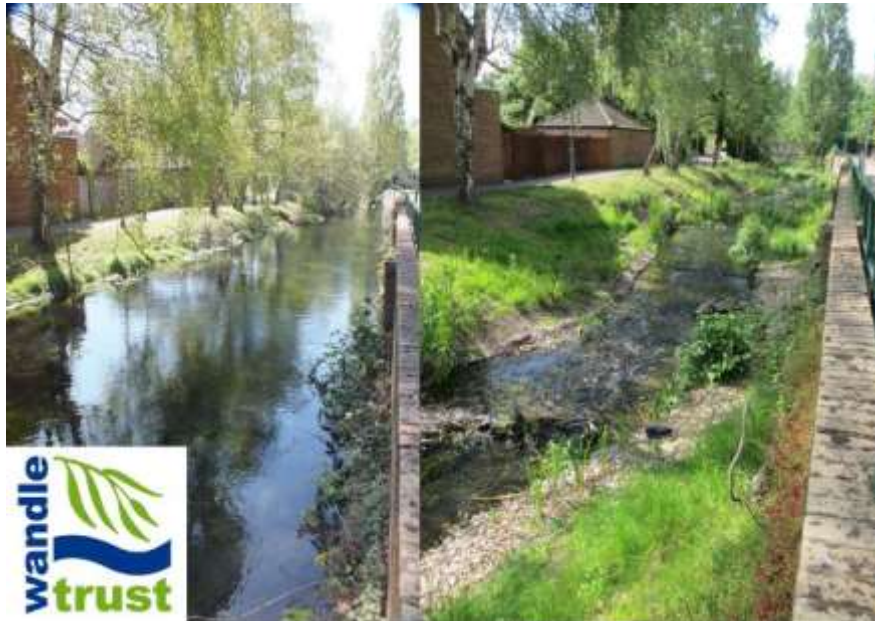
Weir removal and regrading

Figure 17: Before and after: an impounded and ecologically impoverished stretch of river (left) can be renaturalised by removing or reducing the weir, before re-grading and re-meandering the channel through the site (right). Connectivity, sinuosity and natural processes have all been restored to this stretch of the River Wandle in Carshalton, south London.

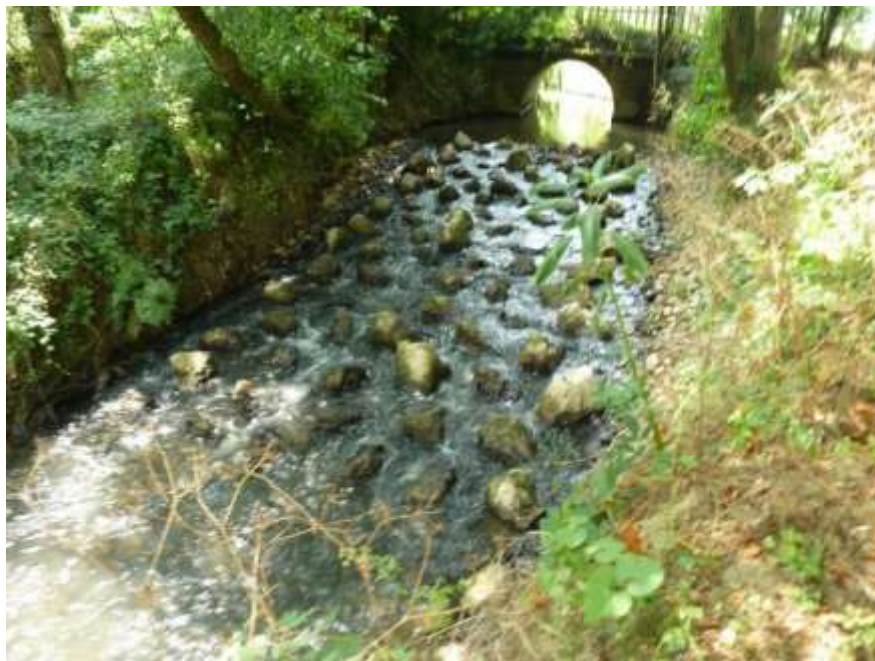
Rock ramp

Figure 18: A rock ramp is an effective fish passage solution when a culvert cannot be modified with baffles or other easements, and a step up into it may need to be 'drowned out'. This example uses a series of erratic perturbation boulders to baffle the flow and ease fish passage.

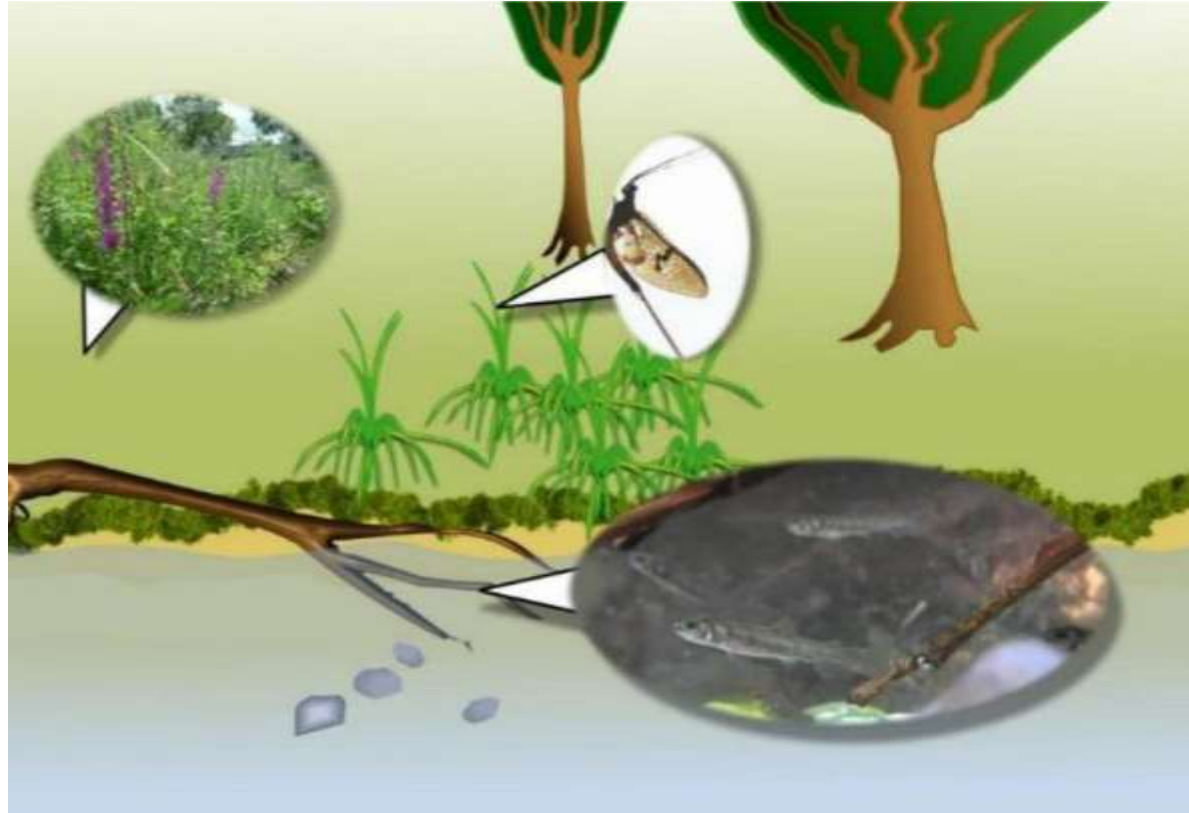
Figure 22: Larger cobbles and submerged 'brashy' cover and/or exposed fronds of tree roots provide vital cover from predation and spate flows for tiny juvenile fish in shallower water (<30cm deep). Trailing, overhanging vegetation also provides a similar function, and has many benefits for invertebrate populations (some of which will provide a ready food supply for the juvenile fish).

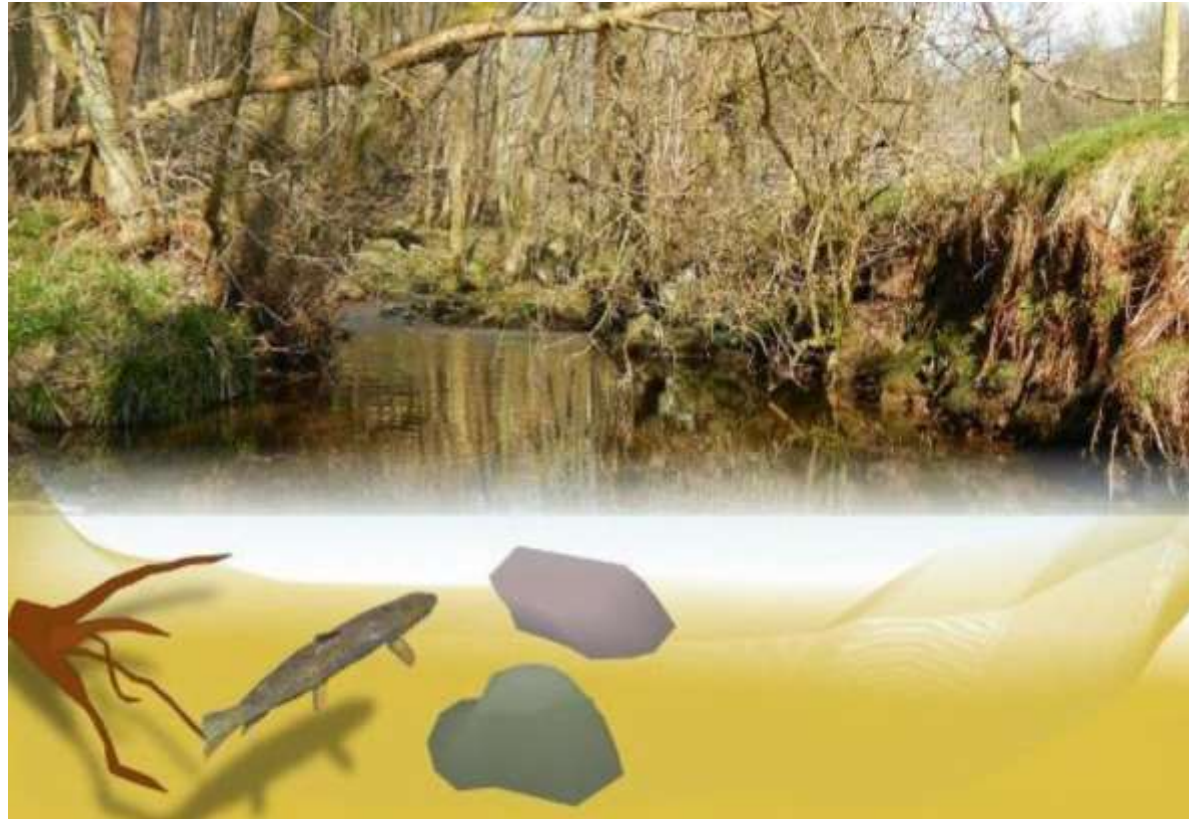
Figure 23: The availability of deeper water bolt holes (>30cm), low overhanging cover and/or larger submerged structures such as boulders, fallen trees, large root-wads etc. close to a good food supply (e.g. below a riffle in this case) are all strong components of adult trout habitat requirements.
