Somerset County Council
Lead Local Flood Authority

Flood Investigation Report

Croscombe, Shepton Mallet, Somerset

11th July 2012

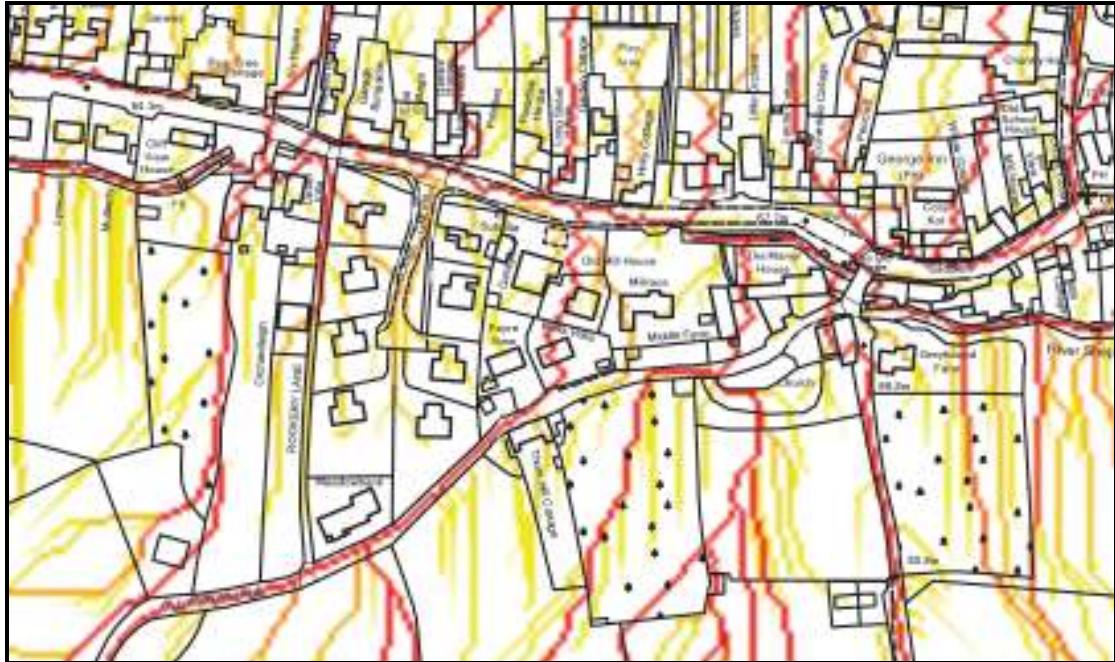
Figure 2 Flow Paths

The natural flow paths for the area have been modelled using LIDAR data and are shown in Figure 2 below (a larger version is included in the back of this report). The majority of the catchment to the south of Croscombe drains to

Old Street Lane and development then prevents water leaving the road, forcing it to flow down to Jack's Bridge. The natural flow routes off Old Street Lane shown in Fig 2 being blocked by Bella-Vista and Middle Farm. The steepness of Old Street means that the road gullies are ineffective at collecting the runoff and would only have been designed to accommodate runoff from the road, not agricultural land.

On reaching Jack's Bridge the flow is prevented from entering the river by the headwall of the bridge and the upstand on the river bank retaining wall. As a result the water drains into the watercourse via the highway gullies. Openings have been created in the headwall to allow flow into the river, but they are not very efficient as they are perpendicular to the flow.

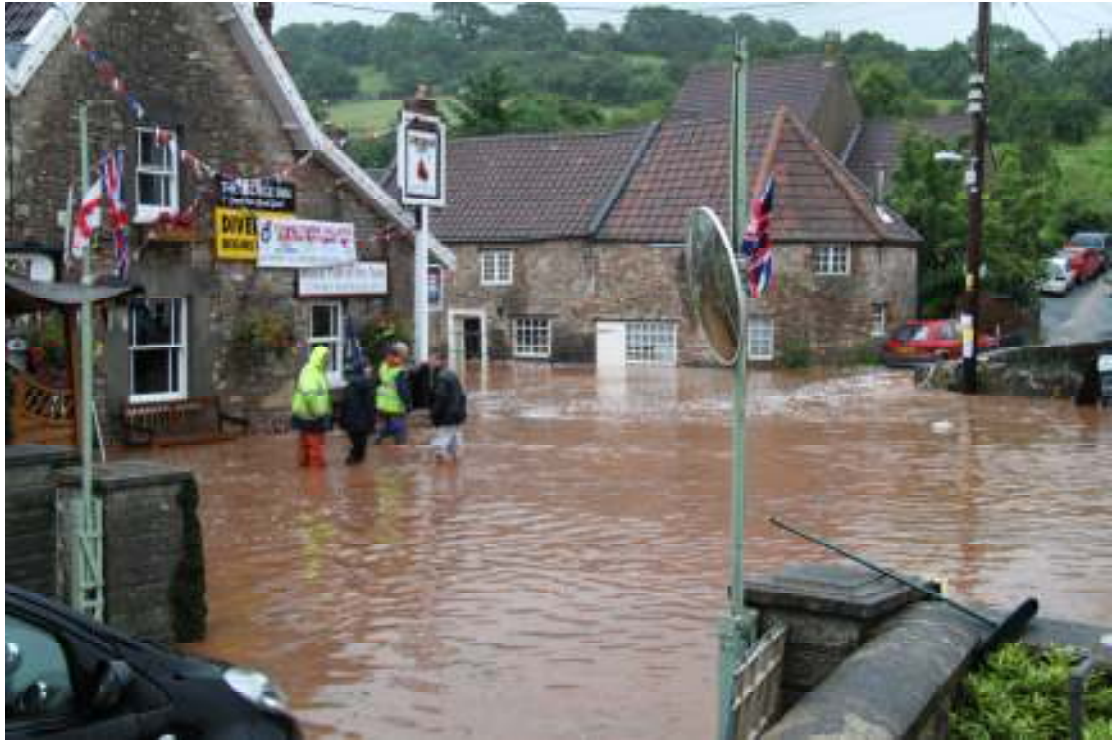
Photograph 1 - The George at 07:52(BST)

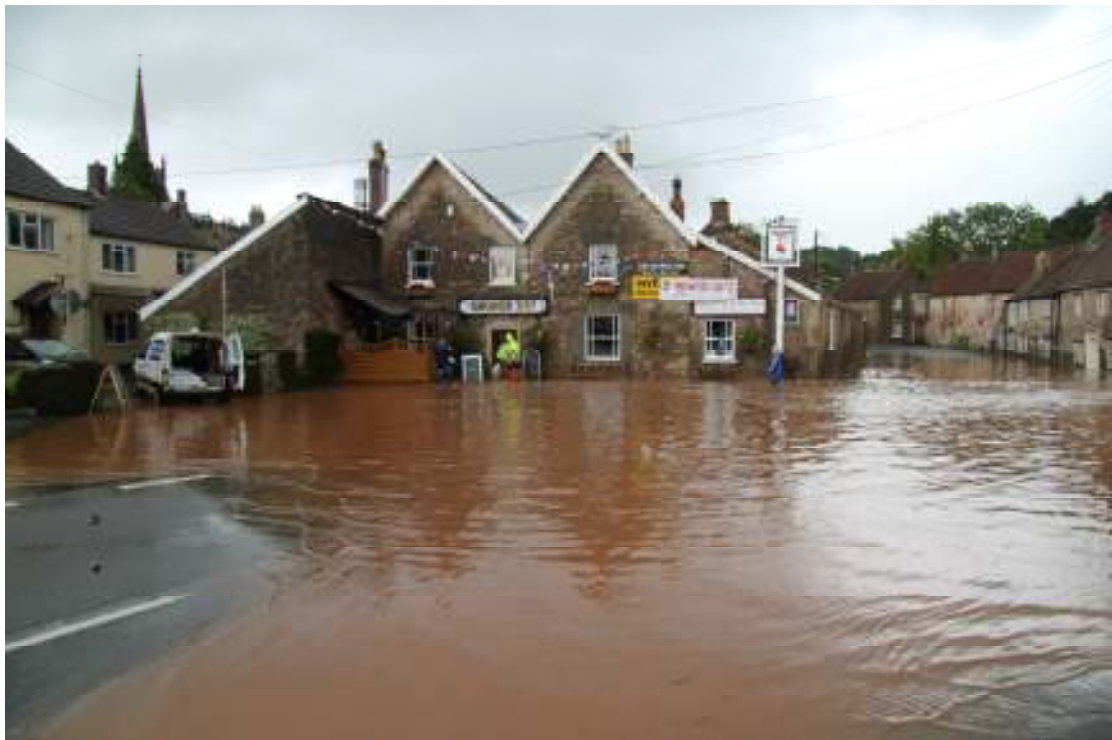
Photograph 2 - The George at 07:58

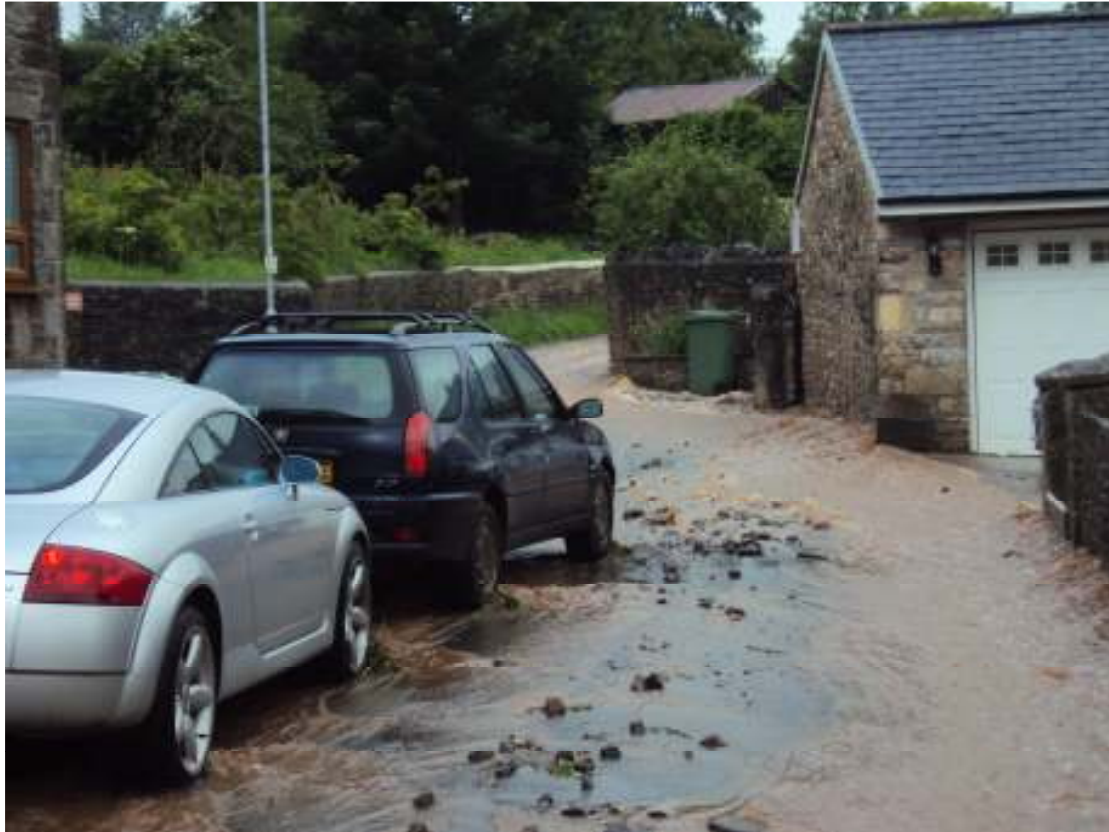
Photograph 3 - Old Street Lane

where it was unable to enter the river. The majority of the surface water flowed down Old Street Lane and Jack's Lane. Runoff from the north side of the village appears to have been accommodated by the drainage system. Surface water flooding affected up to eight properties.

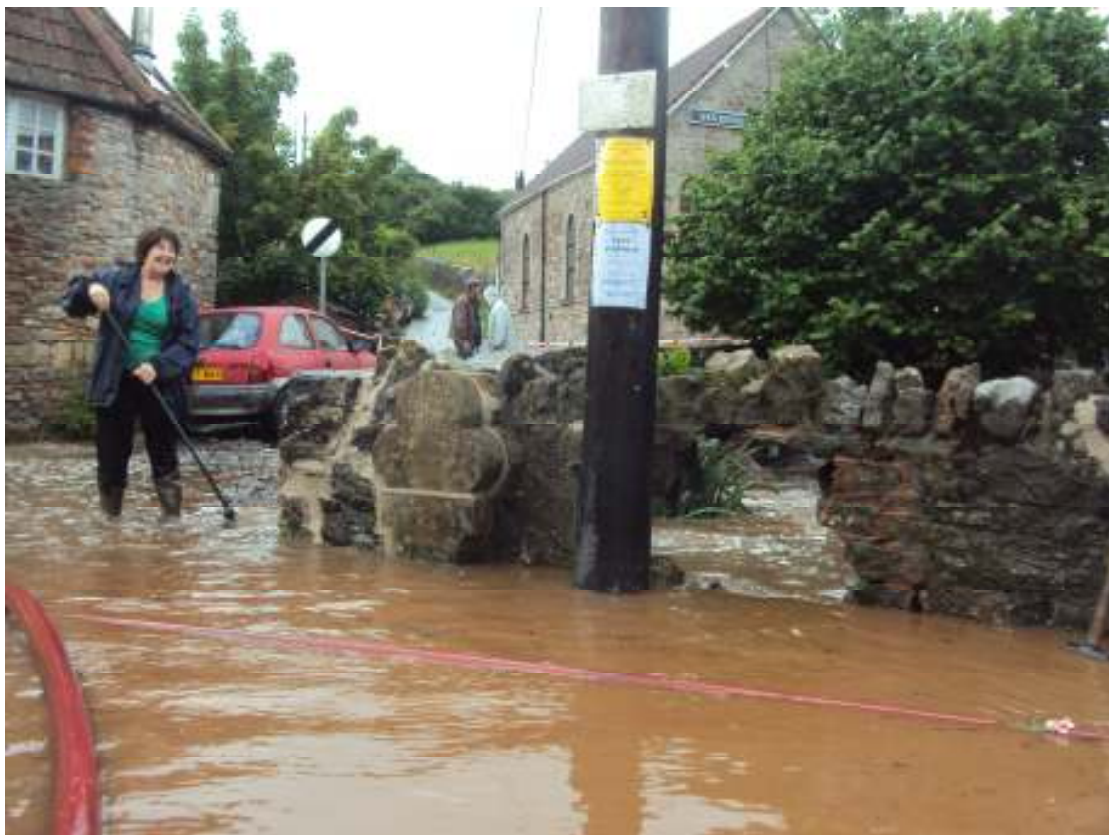
At this time the Sheppey was well below bankfull but the highway drainage was unable to convey the flood water to the river and so residents created a gap in the river wall to allow the majority of the flood water to drain down.

Photograph 4 - Long Street showing opening through wall

During the flood event an opening in the upstand to the river wall was created to allow flood water that had accumulated in the road into the river. Formalising this opening would keep flood depths in the road down to the level of the river bank. This should not be considered as a primary option for dealing with flood water as ground levels adjacent to the river are higher than the road, so water has to build up before it can spill into the river. However it would function well as a backup to other options.

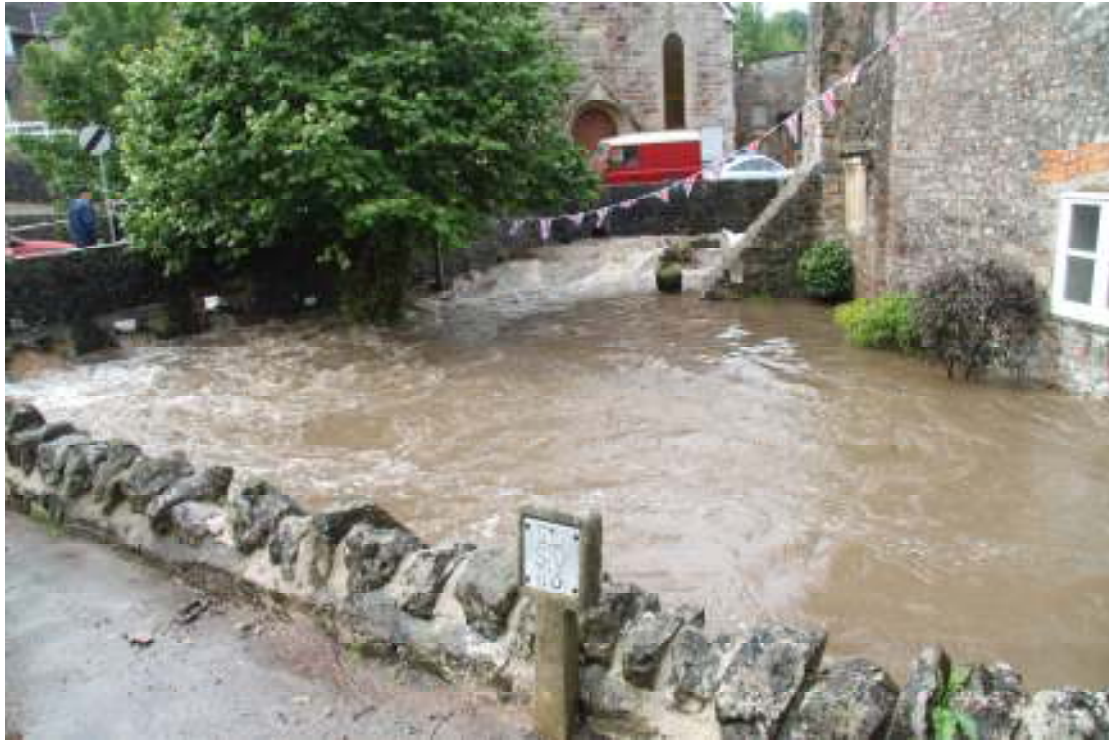
Photograph 5 - Manor House at peak river levels

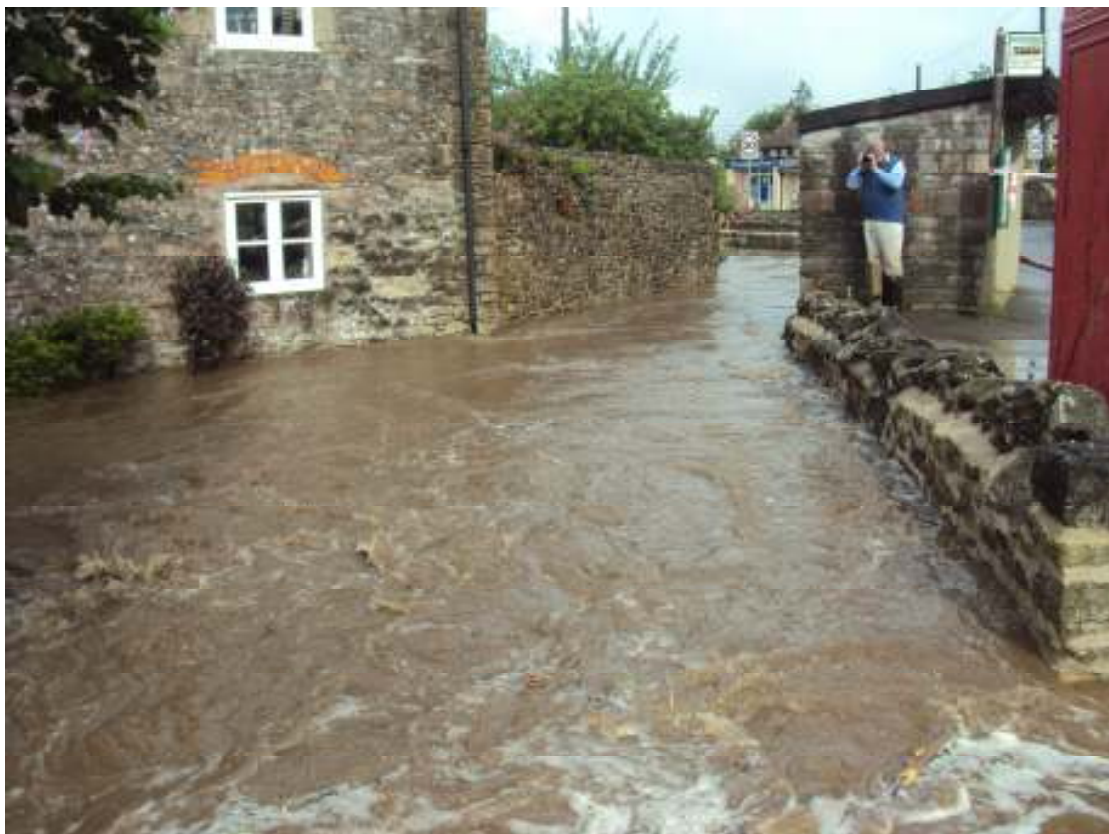
Photograph 6 Manor House at peak river levels looking downstream

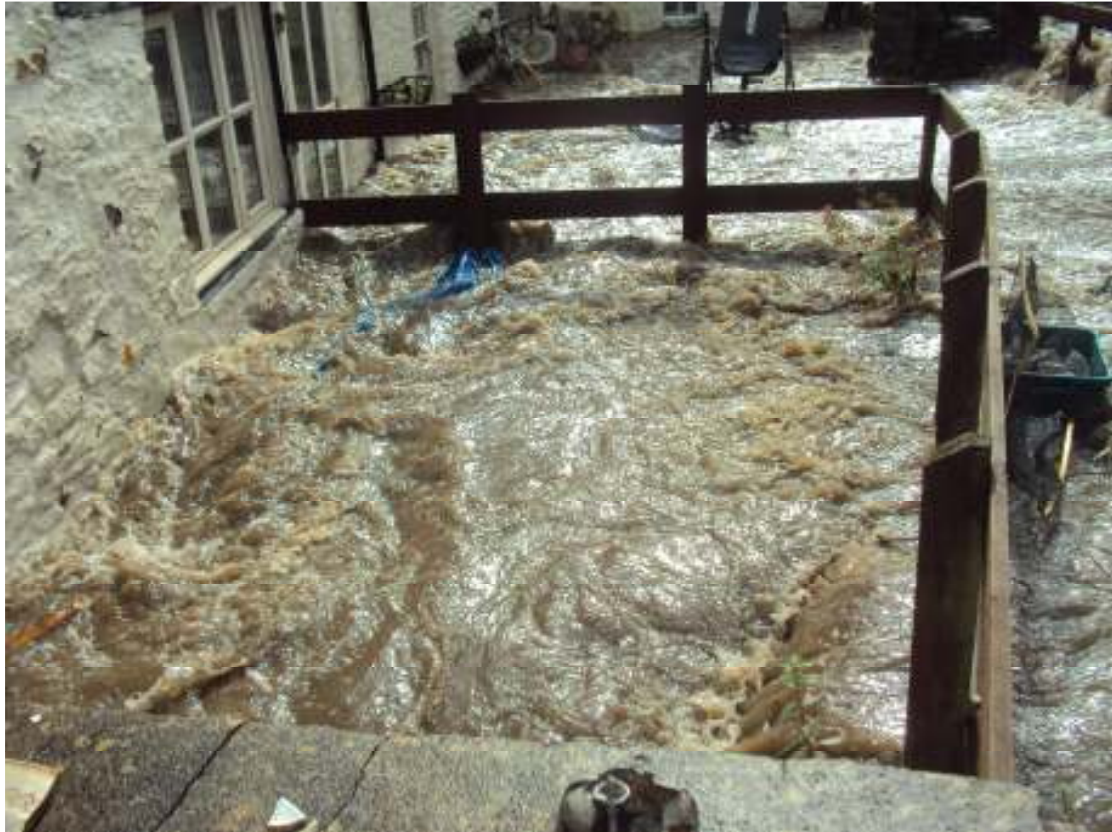
High levels in the River Sheppey resulted in flooding to two properties. The most severely affected property was the Old Forge that lies immediately upstream of Jack's Bridge. A post event survey showed the afflux across Jack's Bridge was less than 300mm and therefore the bridge is not a major restriction to the flow, although it does contribute to the flooding. This property was also affected by surface water flooding. The Manor House, downstream of Jack's Bridge, was flooded through the wall and floor as flow spilled from the millstream to the river. It is likely that had levels in the Sheppey not been raised then this flooding would not have occurred.

Photograph 7 - Old Forge at peak

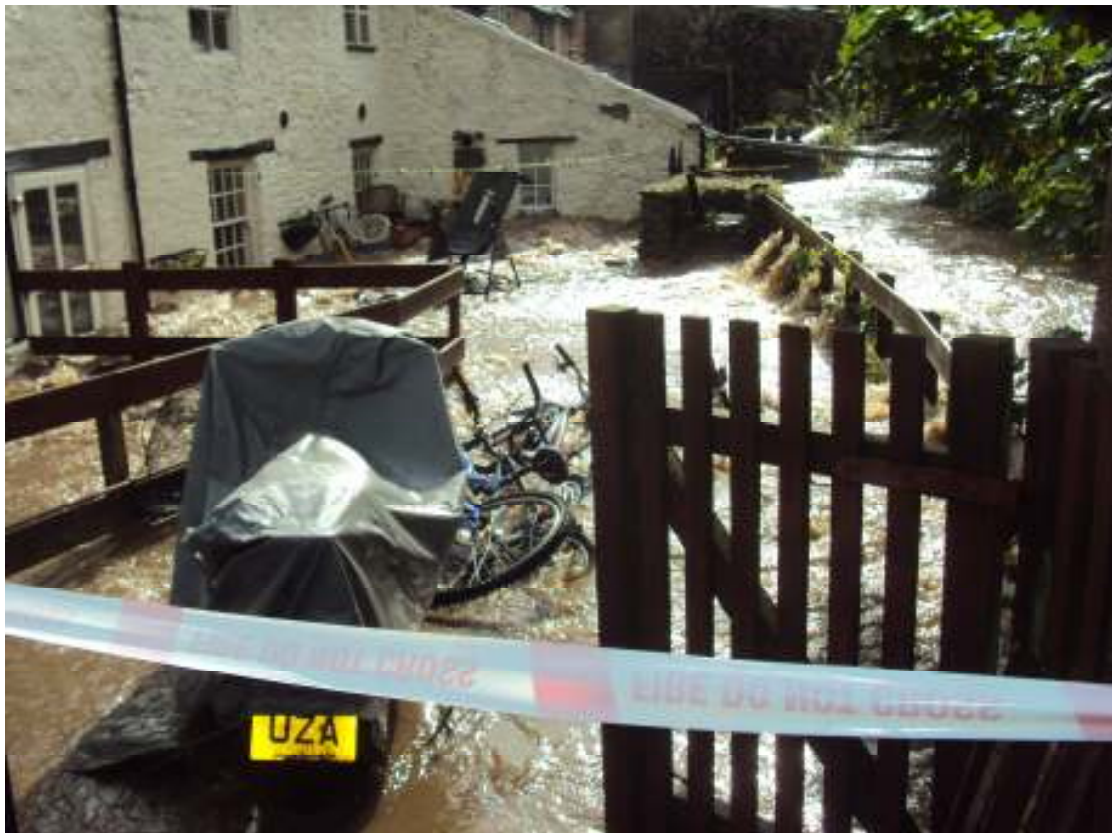
Photograph 8 - Old Forge at peak
