Flood Investigation Report

*Section 19 Flood and Water
Management Act 2010*

**Croscombe, Bowlish
& Shepton Mallet**
3rd & 4th October 2020

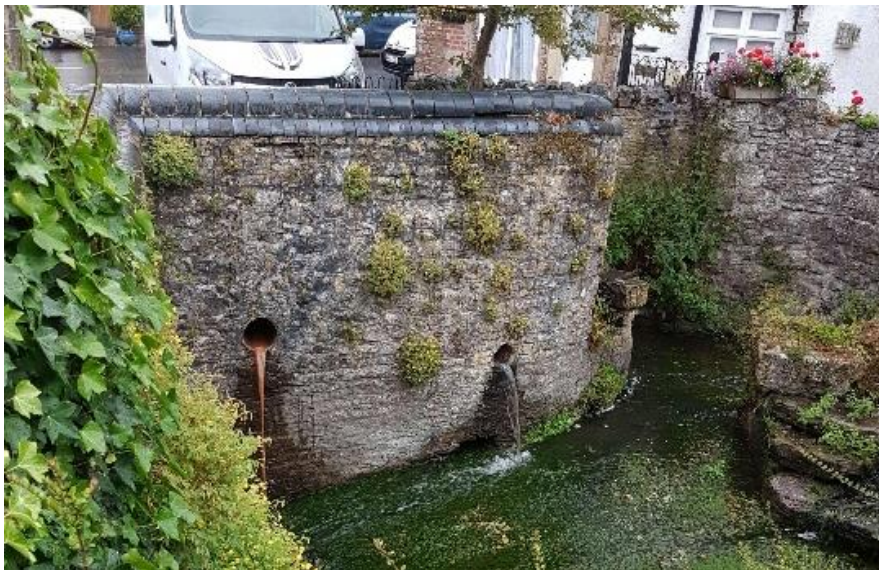
Figure 2 - Croscombe - River Sheppey Watercourse

The River Sheppey has been highly modified by the historic construction of numerous mills that are now disused. The River Sheppey bifurcates at Jack's Bridge with the main river flowing adjacent to Long Street and a millstream (lead) passing under the Manor House, re-joining the River Sheppey before it passes into a culvert for 200m.

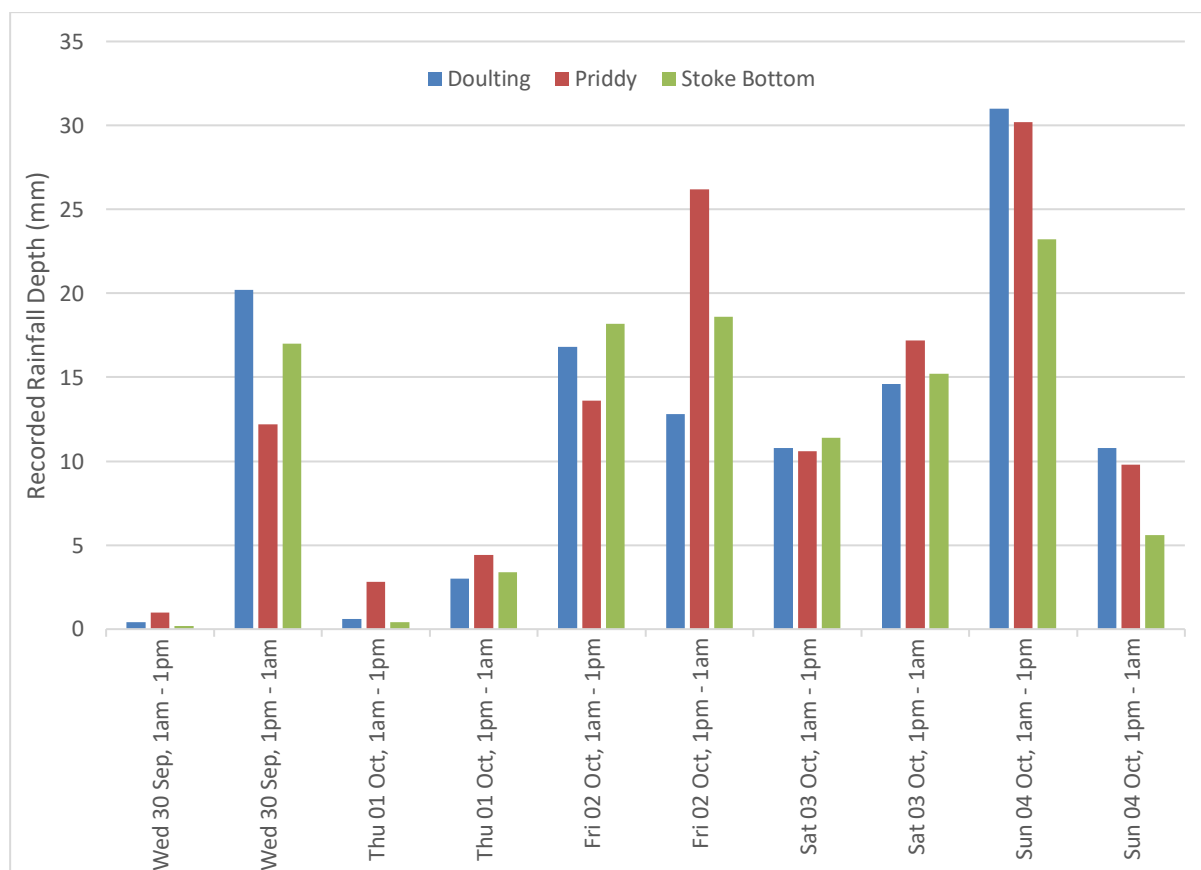
Figure 11 - Rainfall Data

The rainfall data recorded preceding and during Storm Alex is presented in Figure 11 below. The three rain gauges record differing rainfall amounts as the storm passed through the area. However, as illustrated, similar rainfall patterns are experienced across all three gauges and rain occurred on all days leading up to the main rainfall event on Sunday 4th October.

Given the rainfall commenced on the 30th September and continued at various rates through to 4th October, it is believed that the wider catchment was saturated. Thus ground permeability capacity would have been reduced with the consequence of increased surface water run-off and high river levels.

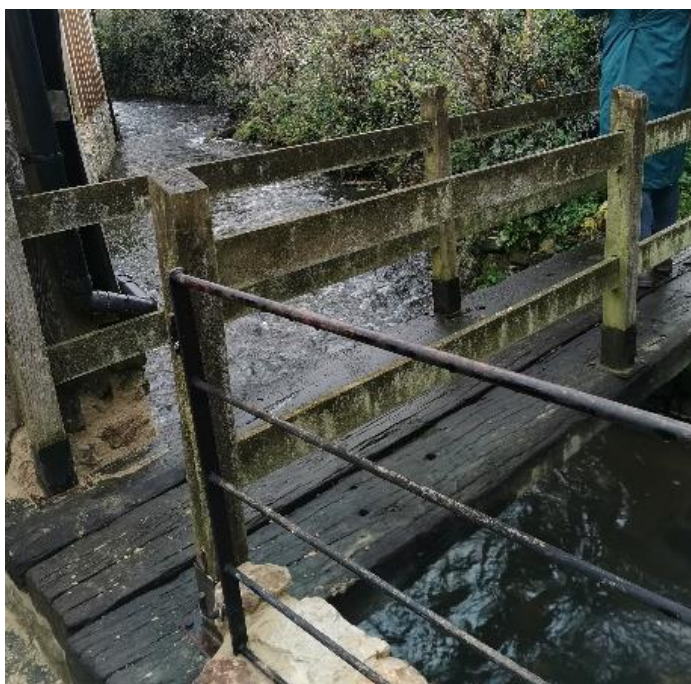
Three of these property owners described how flood water came up through the flagstones of the floor. They believed this to be river water which had tracked underneath the road. One of the property owners reported internal flooding from underneath through the kitchen floor at the rear of the property and 300mm depth of flood water at the front door (facing on to A371 Long Street). The property owners also explained how the river level exceeded the height of some of the properties' private bridges in the rear gardens as illustrated in Figure 13.

Figure 13 - Example of private bridge to the rear of properties on A371 Long Street

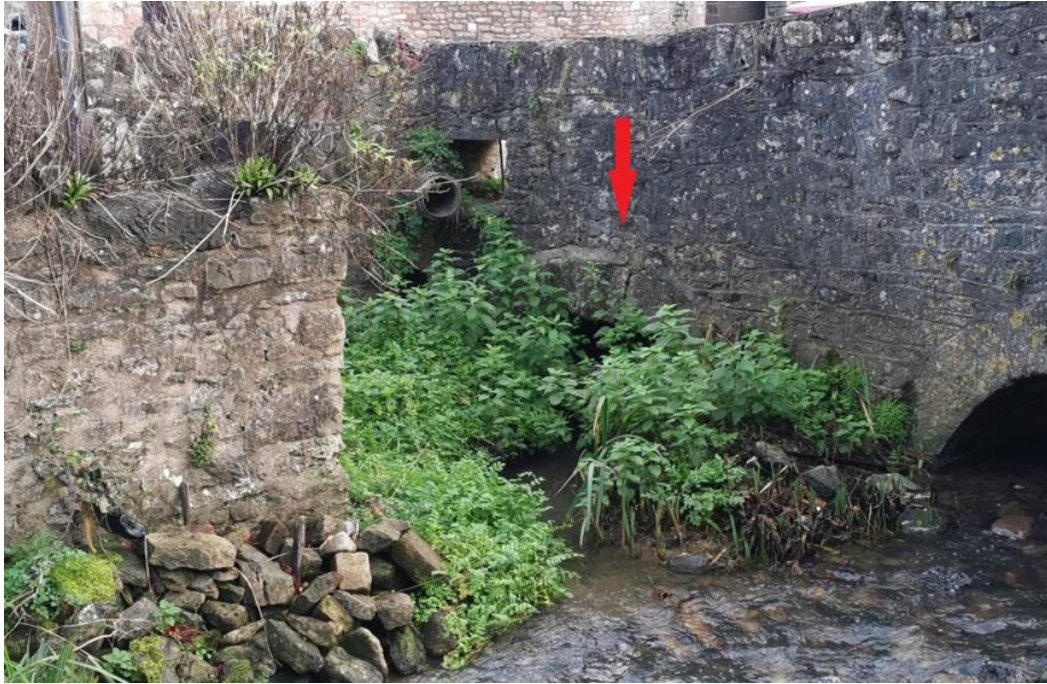
Surface water run-off has historically been a problem at the Old Street Lane, Jack's Lane and A371 Long Street junction with two steep roads converging at Jack's Bridge. In response to flooding in 2008, works were carried out by SCC Highways on Jack's Bridge in July 2009 to alleviate road run-off from Old Street Lane and Jack's Lane with discharge holes / spillways being cut into the bridge's parapet to allow the surface water to discharge into the River Sheppey, as shown in Figure 15. Flood water was seen to be flowing through these spillways on the 3rd and 4th October 2020.

Figure 14 - Jack's Bridge showing the culvert adjacent to A371 Long Street blocked with vegetation

Following on from the CCTV survey, the locations of conditions of all weirs and culverts in selected areas to be mapped, pinch points and trouble spots identified, and responsibility and opportunity for maintenance and upgrade of each stretch to be established. This to include Bowlsh (especially around Ham Mill), in Croscombe, particularly around Jacks Bridge and Millrace.

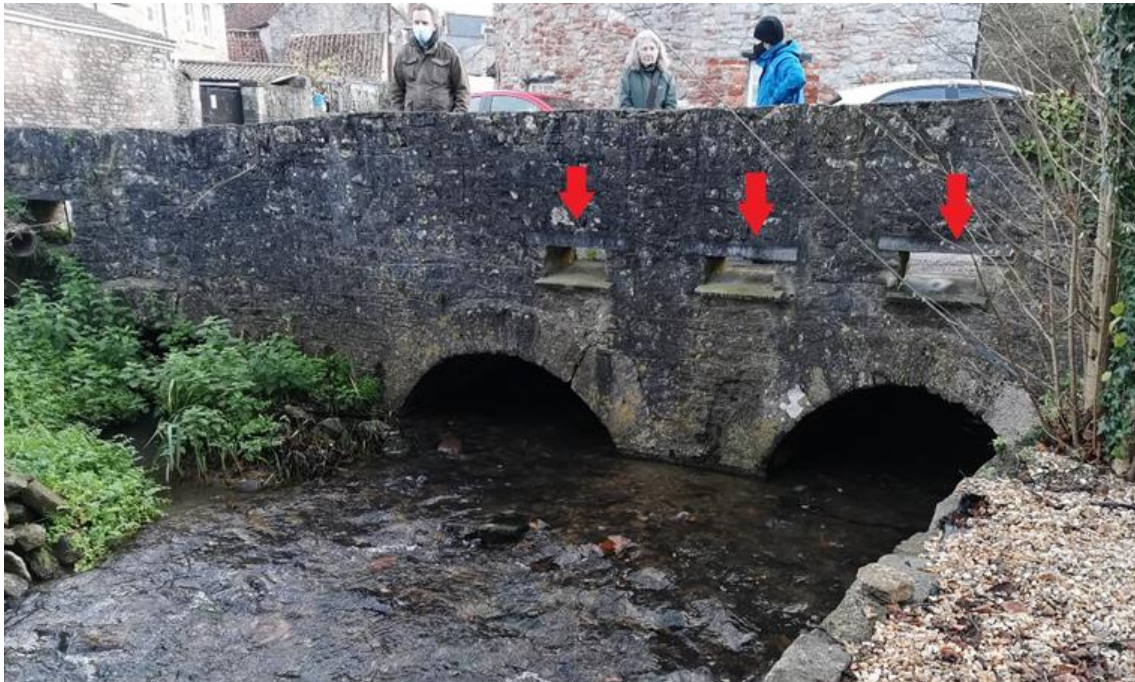
Figure 15 - Jack's Bridge downstream parapet with three spillways

Whilst the concerns of the community are noted, the photograph shown above in Figure 15 indicates the presences of large stones and cobbles forming the bed of the watercourse and these may be considered significantly larger than the carrying capacity of the River Sheppey. As such, significant changes to bed levels may be considered limited however this can be reviewed as part of the forthcoming Sheppey Catchment Study and further information is provide in Section 0.

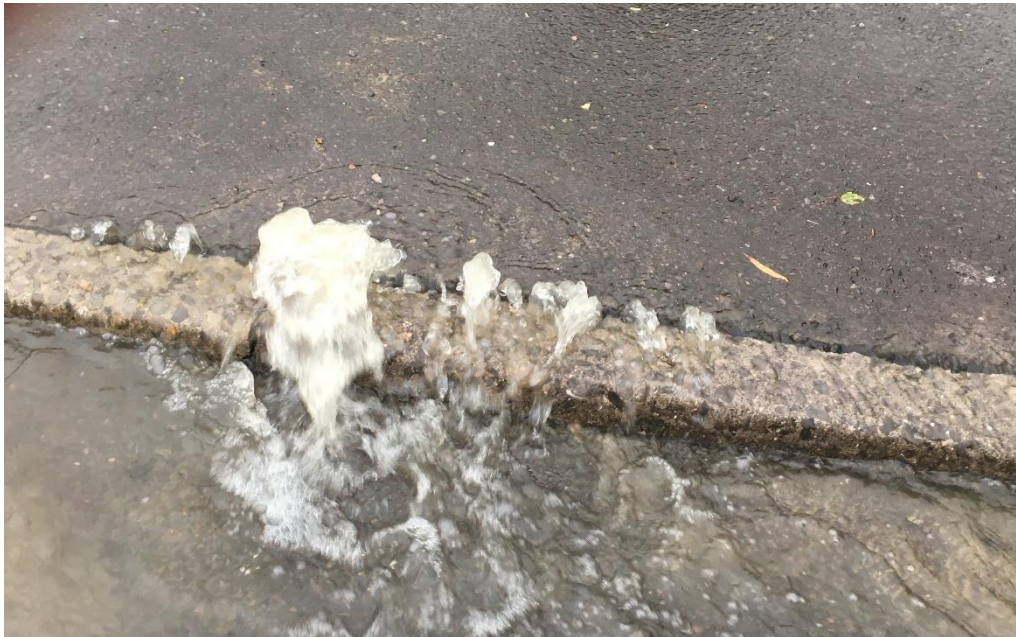
The Croscombe Flood Committee also suggested that the gully located opposite the village store on Long Street, immediately upstream of the culvert's inlet, experienced surcharging from the River Sheppey, along with water emanating from the junction between the road surface and kerb, as shown in Figure 17. Consequentially, Long Street acted as a conduit for exceedance to flow west along Long Street with the area of flooding stretching from west of The George Inn as far as the public footpath known locally as Elderwell (illustrated in Figure 12).

Figure 17 - Cracks in Long Street from which water was reported to be emanating.

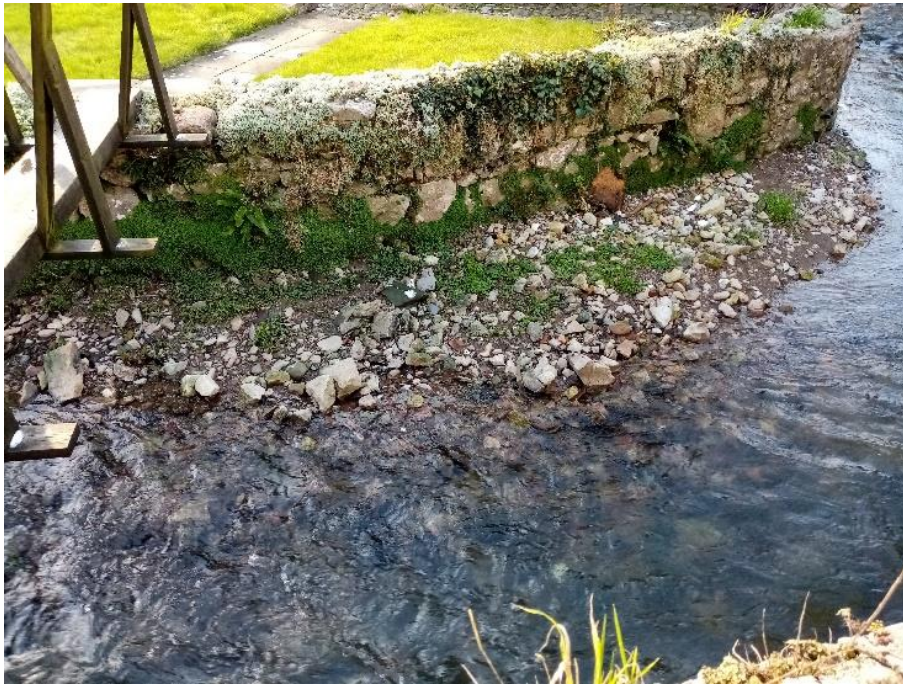
Figure 18 - River Sheppey inside bend deposition (A371 Long Street and Fayre Way junction)

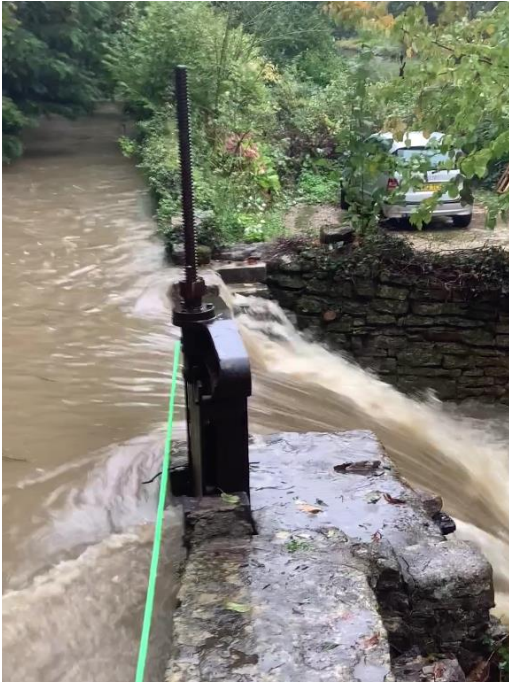
Further downstream, it is understood internal property flooding occurred at Ham Mill to a depth of circa 900mm and at Weirside, the flows in the river Sheppey were observed spilling from the weir and down into the culvert underneath the A371, this is shown in Figure 20. Flows subsequently seeped through the culvert walls causing internal flooding to the ground floor of Weirside.

Figure 20 - River Sheppey spilling from the weir at Weirside

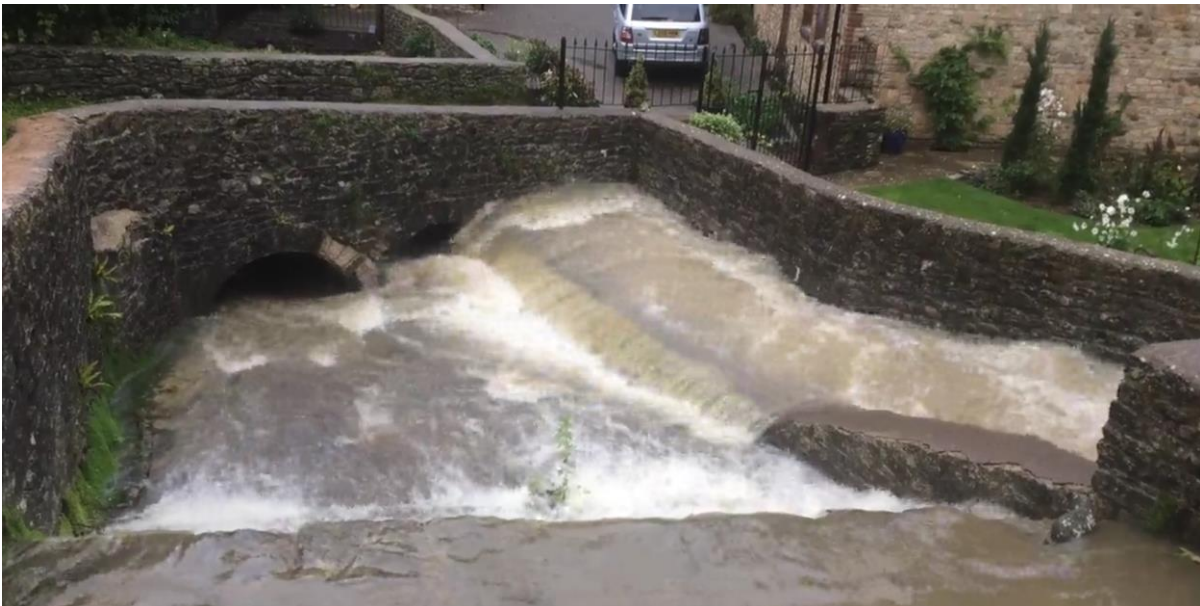
Finally, downstream in Darshill, it is understood the volume of water exceeded the normal operation of the Darshill weir structure, a former mill/control structure. This is illustrated in Figure 21 below and it is understood during normal conditions, flows pass through the eastern culvert however during this storm event, all three culvert barrels were utilised.

Figure 21 - Darshill Weir in full flow

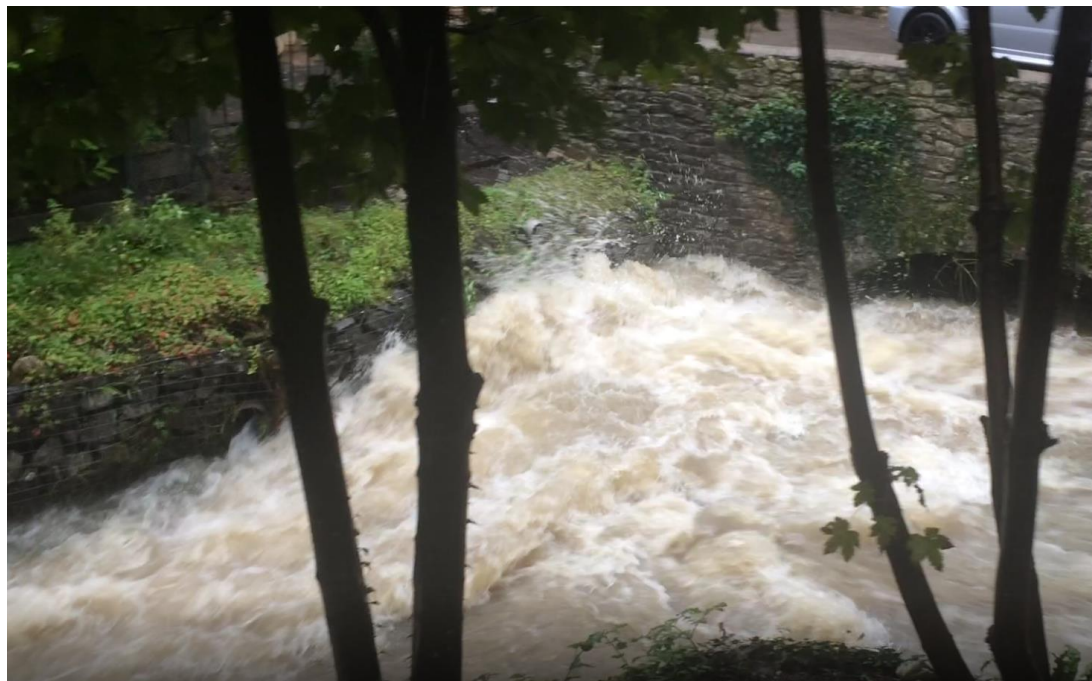
Immediately to the north of the weir and culverts, the watercourse bends eastwards 90° and the bank was reinforced with gabion baskets as part of a recent development however concerns have been raised by residents regarding the erosion and stability of this bank; this is shown in Figure 22.

Figure 22 - Darshill Gabion Bank

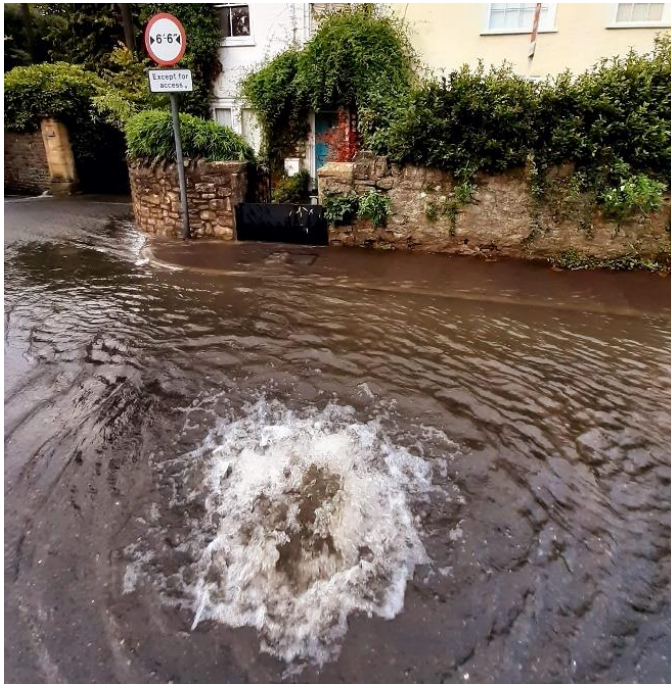
It is water was observed surcharging from Manhole ref 0750 along the Collett Park Stream culvert along with foul sewer manhole 0700. The locations of these are illustrated in Figure 23 with further photographs provided in Figure 24 and Figure 25.

Figure 24 - Surcharging from Collett Park Stream culvert (manhole ref: 0750)

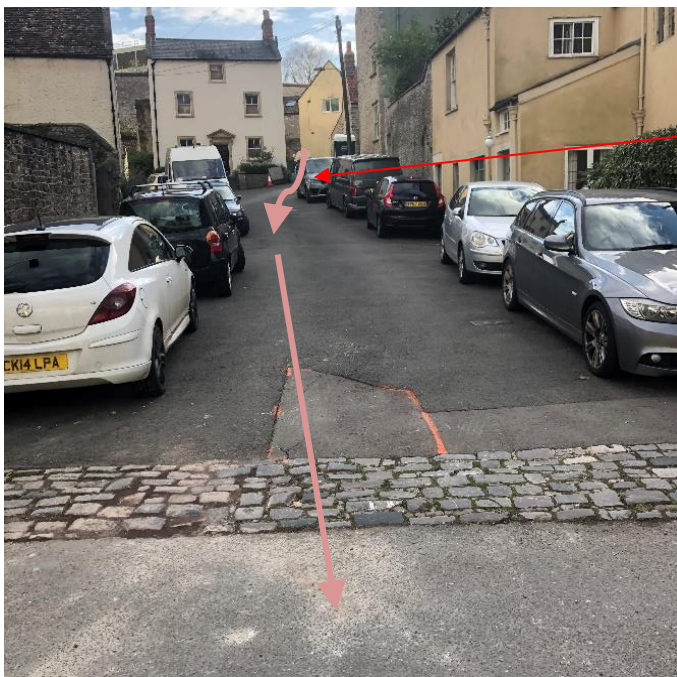
Figure 25 - Flow path from Gaol Lane into Leg Square

Flows along the Gaol Lane / Leg Square link were described as a 'waterfall'

Flows continued down into Leg Square
