# Croscombe Parish Council

## Report of the flood of 4<sup>th</sup> January 2024

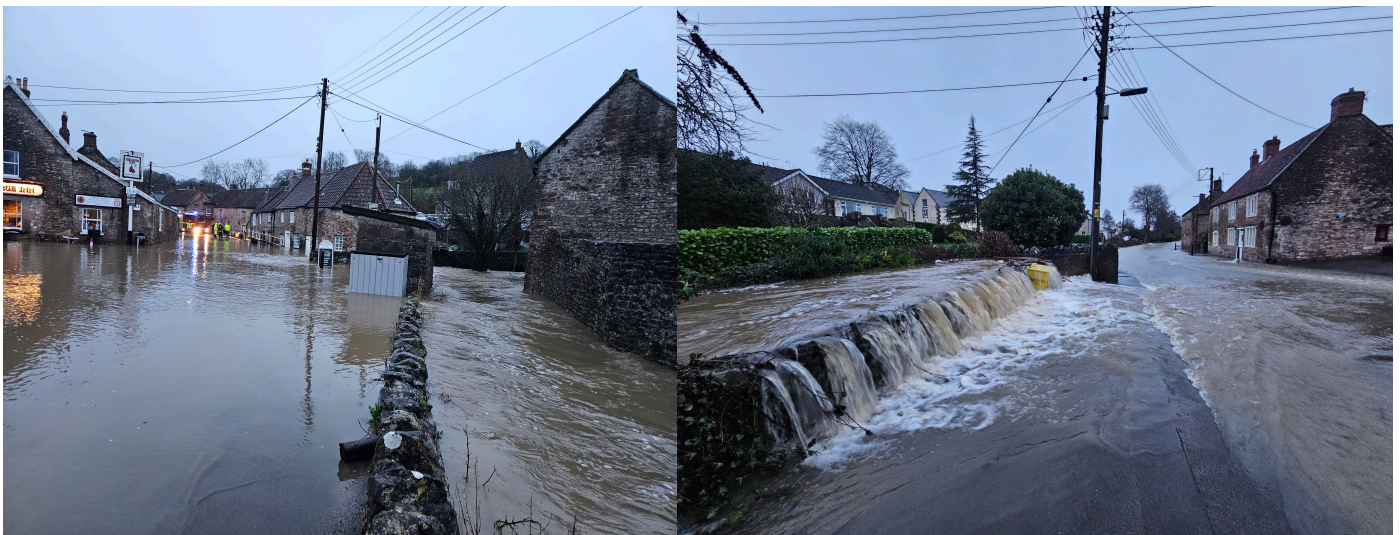
**Jacks Bridge**

**Culvert overflowing**

The culvert needs to be checked to ensure that there are no blockages and any damage found must be repaired. If all is found to be good then the capacity is inadequate and consideration needs to be given to replacing the culvert or an alternative solution such as laying a pipeline to supplement the culvert carrying capacity. Calm Ref. RM.C.13

### **3. Improve the approach and exit of the river channel at Jacks Bridge**

The current layout is based the needs of Mills where ponds were used to store river flows Improving the approach and exit at the bridge will help to smooth the flow of water and reduce the level of the river. When this is combined with the maintenance of the stream bed then this would reduce the river level and the incidence of flooding in the area.
